# FORM B – BUILDING

**Town/City:** Lexington

**Address:** 107 Bow Street

**Style/Form:** Bungalow

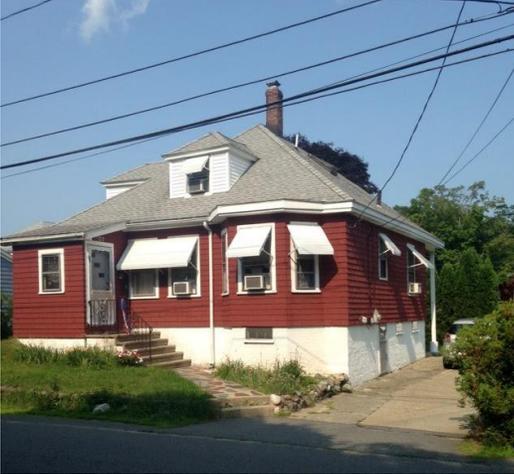
West (façade) and south elevations

The nearly square main block rises from a concrete foundation to a high hip roof with a center chimney at the ridgeline. Walls are clad with wood shingles and trimmed with a flat fascia board. Windows typically have 6/1 double hung sash with band molding. The front façade (west elevation) presents a left entry vestibule with a low hip roof, single window facing the street, and single-leaf door facing the right side of the property. Centered in the front façade are two 6/1 windows and to the right is an angled bay window containing three 6/1 windows and one awning window in the basement level. A hip roofed dormer is centered on the façade and wrapped in vinyl siding; it contains a single 6/1 window and plain flat fascia board.

The south (right side) elevation of the main block contains two 6/1 windows on the main floor and an offset, single-leaf door and two small awning windows at the partially exposed basement level. The north (left side) elevation of the main block contains two large 6/1 windows and a single small 6/1 window. A hip-roofed dormer is wrapped in vinyl siding; it displays a single 6/1 window and plain flat fascia board. An open porch is just visible at the rear of the building, recessed beneath the main roof and supported at the back right corner by a square post.

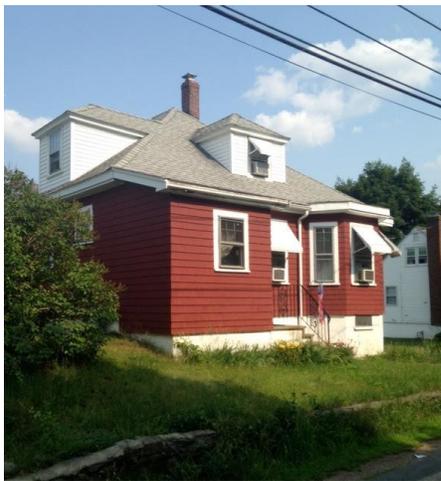
North and west (façade) elevations
