FORM B – BUILDING

Town/City: Lexington

Address: 135 Cedar Street

135 CEDAR STREET

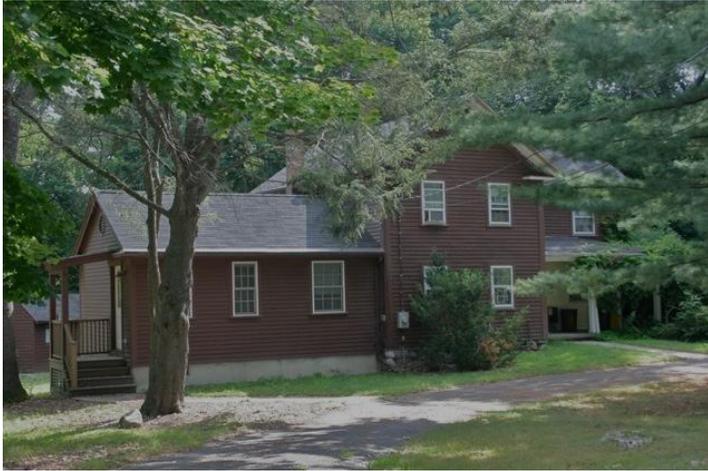
Left side and front (façade) elevations

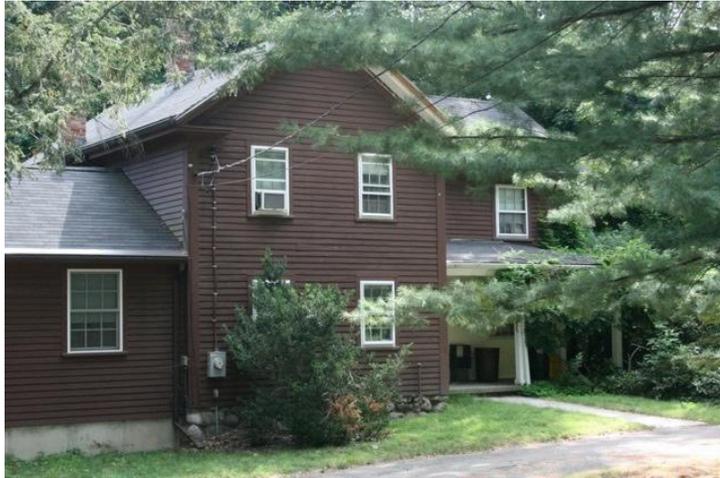
Front (façade) elevation: Detail

The main block rises two stories from a fieldstone foundation to two gabled wings with low pitched roofs and gable returns. The front-gabled wing has two chimneys: one exterior chimney near the center of its left side and one interior chimney on its left slope near the center and the ridge line. Walls are clad with wood clapboards and trimmed with flat corner boards and a flat fascia board with bed molding. Windows typically have 6/6 double hung sash with plain flat casings. The façade (street) elevation of the front-gabled wing has two windows on each floor (no attic window). On the street façade of the side-gable wing, a one-story porch supported by square posts spans the first floor, its hip roof sheltering an offset single-leaf door and single window; two windows are set above.

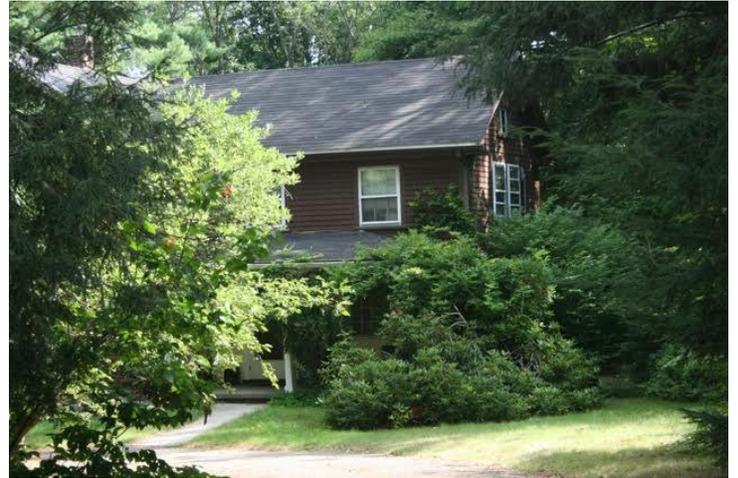
Front (façade) and right side elevations

The right side elevation of the side-gabled wing of the house features a set of paired windows at the second floor and a small square window in the attic; the first floor is not visible from the street. On the left side of the main block is a one-story, side gabled addition set on a poured concrete foundation; its clapboards and trim echo the main block. The street façade of this addition has three asymmetrical windows of two different sizes; its gable end has an offset single-leaf door, a wood porch with wood steps, railing, and square posts, and a low shed roof.

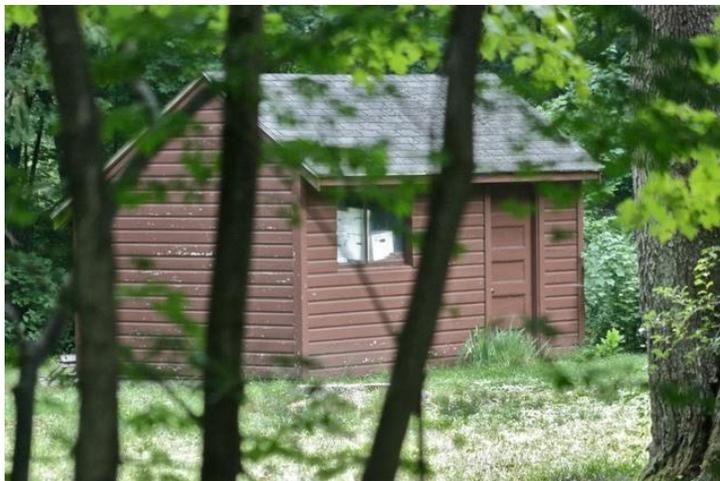
Shed: Left side and front elevations

In back and to the left of the house is a small wood-frame shed with a side-gabled saltbox roof, shiplap siding, and narrow flat corner boards. Its long façade (facing the house) has an offset door with horizontal panels and a horizontal window to the left.
