FORM B – BUILDING

Address: 23 Cedar Street

Style/Form: Four-Square

23 CEDAR STREET

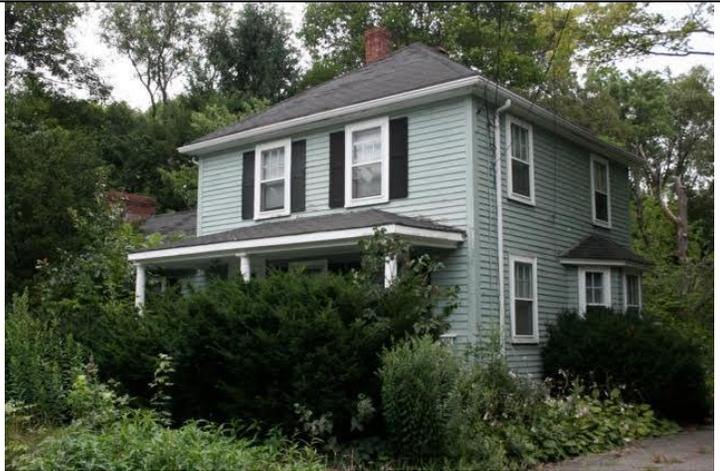
Front (façade) and right side elevations

Condition: poor

23 Cedar Street occupies a small, flat lot with a modest front setback. The house appears vacant and the lot is overgrown, although it appears to originally have had a small lawn in the front. A narrow paved driveway leads to a garage near the back corner of the lot. The house consists of a 2-story, square main block with a side ell.

The small main block rises from a fieldstone foundation to a low hip roof clad with asphalt shingles. A chimney is located near the peak on the left slope of the roof. Walls are clad with wood clapboards and trimmed with narrow flat corner boards and a narrow bed molding at the eaves. Windows typically have 6/1 wood sash (original or early) and flat casings with narrow band molding. The front façade has a full-length front porch with three Tuscan columns and a wood railing with square balusters. Behind the porch on the first floor are an offset door and two windows. Two windows are symmetrically arranged on the second floor. Wood steps to the front entrance have square posts with ball finials. A one-story side gabled addition extends to the left, flush with the façade of the main block; it rises from a poured concrete foundation. This ell has two windows facing the street and a broad exterior chimney on its side elevation. Above the ell, the left side of the main block has one window on the second floor.

The right side elevation of the main block has two window bays, with a single window and a small angled bay window on the first floor and two single windows above.

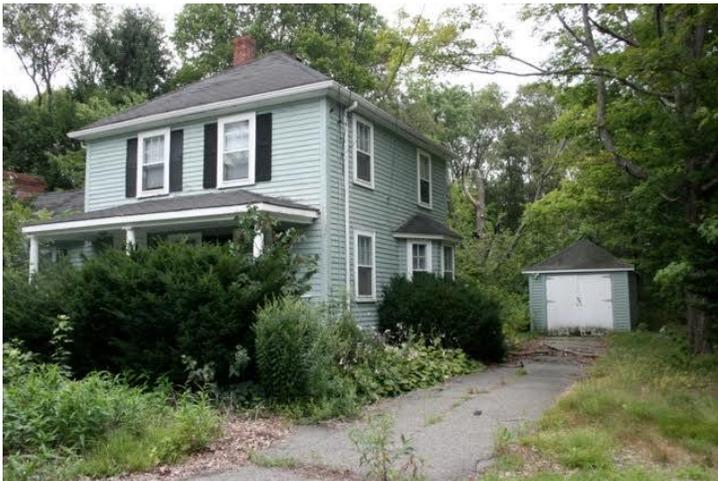
Front (façade) and right side elevations; garage

A small, detached garage to the back and right of the house has a hip roof with flared eaves and exposed rafter ends. Walls are clad with wood clapboards and flat wood trim. The structure's one vehicle bay is enclosed with a pair of double-leaf, hinged doors constructed of vertical wood boards.

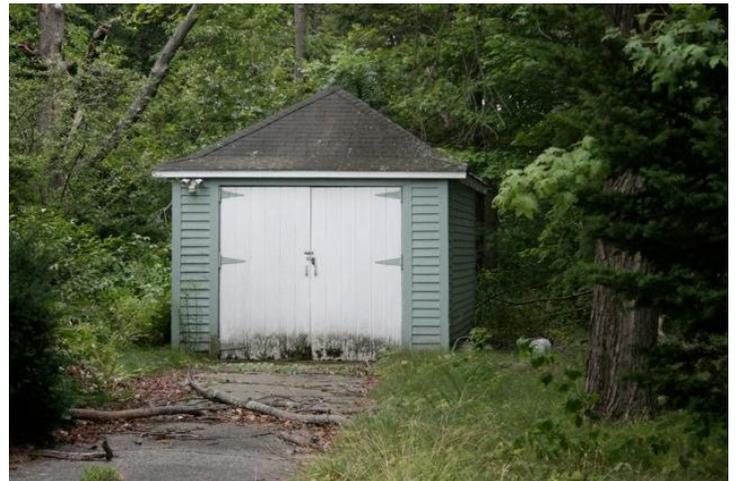
Garage: Front (façade) and right side elevations
