INVENTORY FORM B CONTINUATION SHEET

LEXINGTON

33 HILL STREET

MASSACHUSETTS HISTORICAL COMMISSION

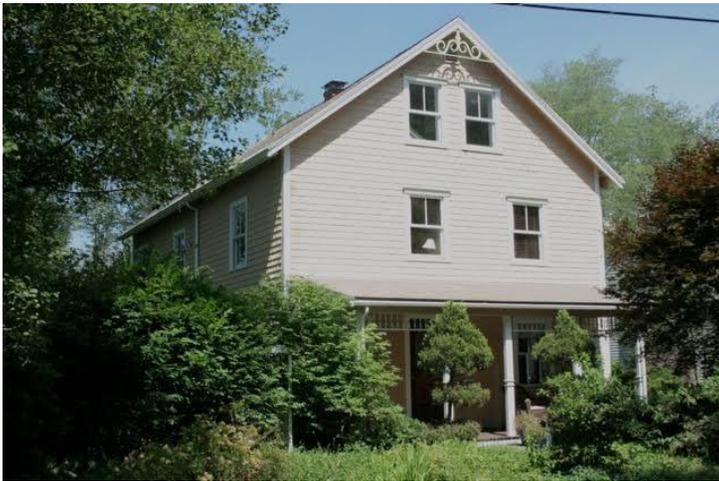
Left side and front (façade) elevations

33 Hill Street occupies a long, narrow lot that slopes down to the back of the property. The house has narrow front and left side set backs, taken up by ground cover, shrubs, and small trees. A paved driveway occupies most of the side setback on the right side; a wood walkway leads between the driveway and the front porch. The house consists of a 2 ½ story, roughly rectangular block.

The building rises from a fieldstone foundation with deeply recessed joints and a raised basement at the back to a front gable roof. The roof has exposed rafter ends and no gable returns. A chimney is located on the right slope of the main roof, near the center and the ridgeline. Walls are clad with wood shingles and trimmed with narrow flat corner boards. A decoratively sawn, flat wood grille spans the tip of the gable peak. Windows are typically 2/1 double-hung sash with flat casings. Windows on the front façade have an additional applied header board with a narrow cornice molding. The front façade contains a full-length, shed-roofed porch across the first floor, with slender square posts and a spindle railing across the top. The off-center, single-leaf doorway is flanked by a window on each side on the first floor. Two asymmetrical windows are set on the second floor, surmounted by two windows centered in the half story.

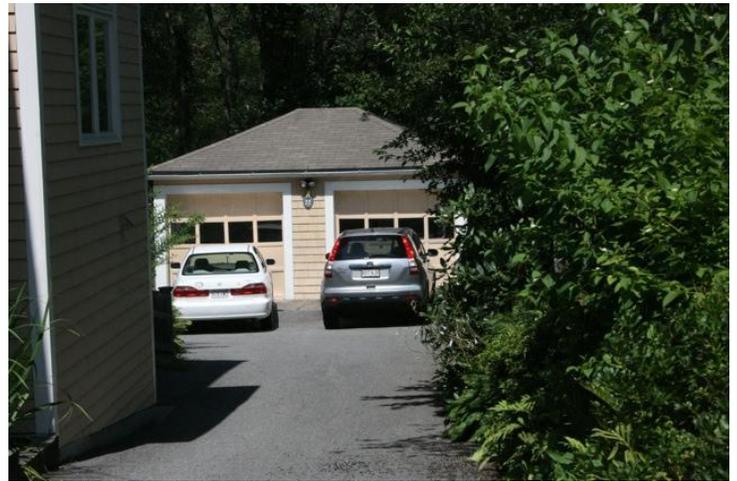
Garage: Front (façade) elevation

A detached garage stands behind and to the right of the house. Clad in wood shingles, it features a hip roof, two individual vehicle bays, and flat wood trim.
