# FORM B – BUILDING

**Town/City:** Lexington

**Address:** 58 Hill Street

58 HILL STREET

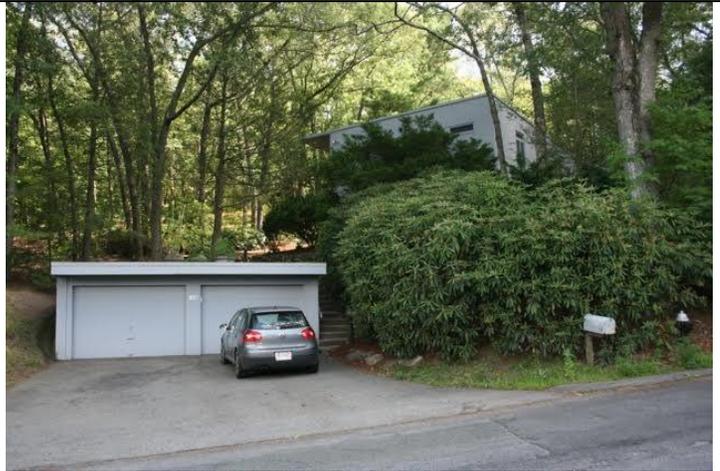
## Photograph

Front (façade) and right side elevations of house; front façade of garage

The house consists of a roughly rectangular block that rises two stories (including a fully raised basement) from a poured concrete foundation to a butterfly roof that defines two distinct sections of the building. Walls are clad with vertical wood boards. Windows are a variety of banded picture windows and casement sash, without trim. The front façade elevation, oriented towards the garage, contains an off-center entrance on the lower level with a single-leaf flush panel door. Centered above is a very narrow band of five glazed openings, which may be fixed or awning sash.

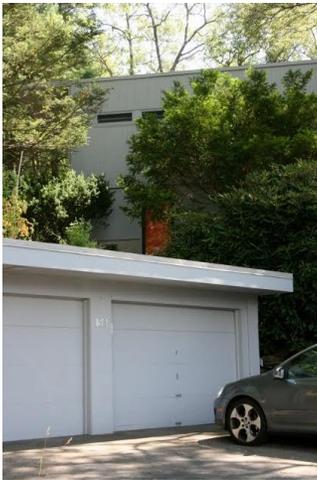
Built into the hillside, the detached garage has a shallow shed roof that slopes up to the front, supported by poured concrete side walls. Its two vehicle bays have flush panel wood doors.

Front facades of garage and house

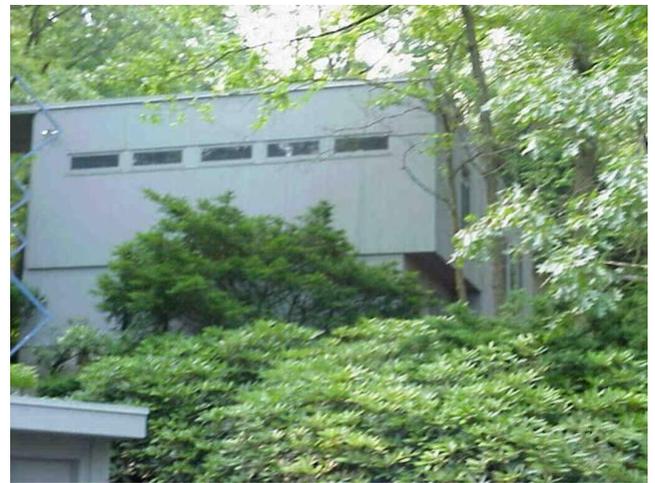
Assessors' photograph:  
Front (façade) and right side elevation of house

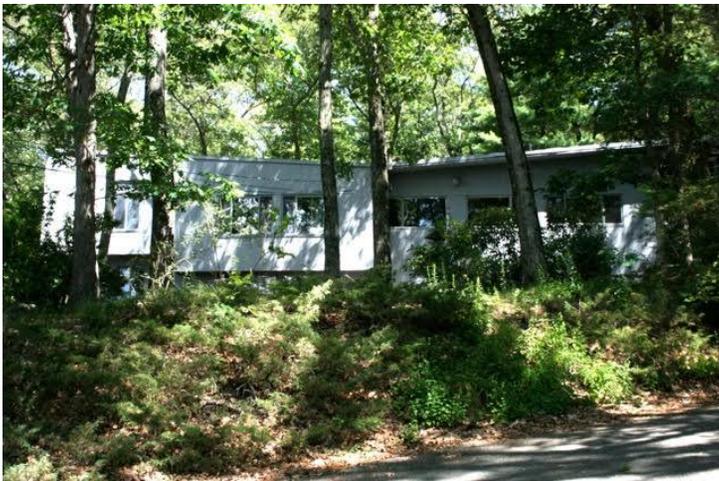
On the long right side elevation, the upper story is cantilevered over the raised basement under the left shed roof. On the other end of this elevation is a tall, screened porch with widely overhanging eaves. The only feature visible on the left side elevation is a deep overhanging roof towards the front. The back elevation is not visible from the street.

Right side elevation

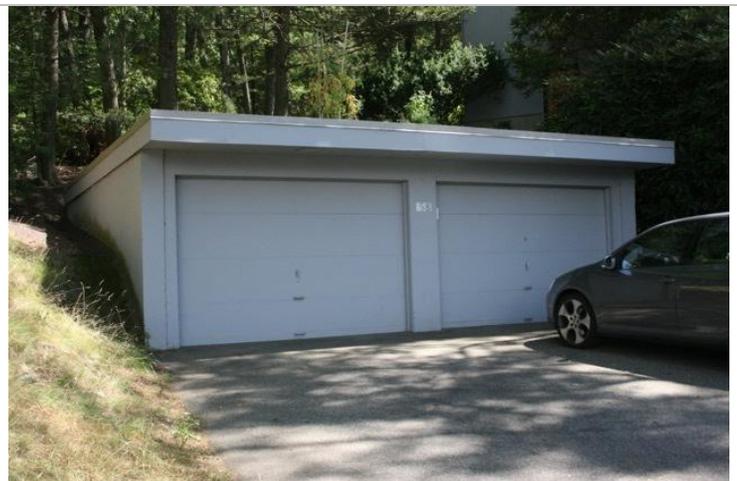
Garage: Left side and front (façade) elevations
