# FORM B – BUILDING

**Town/City:** Lexington

**Address:** 17 Holland Street

17 HOLLAND STREET

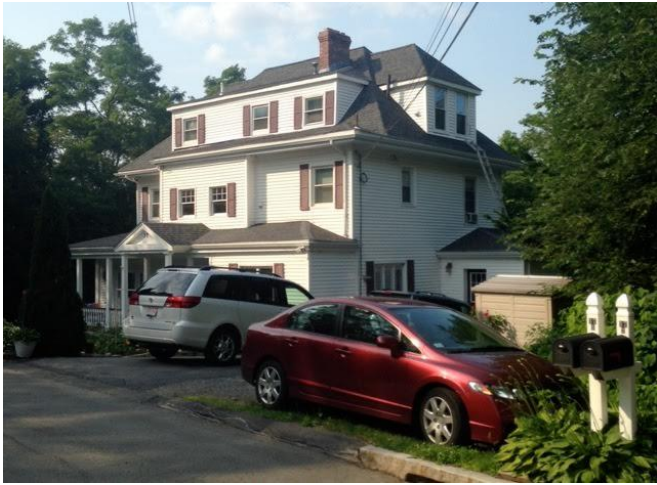
South (façade) and east (right side) elevations

The three by two bay main block of the house rises 2 ½ stories from a stone foundation to a high hip roof with a chimney on the right front slope. The south (façade) and east elevations each contain a one-story appendage. Walls are clad with vinyl siding and trim. Windows typically have 1/1 and occasionally 6/1 double-hung replacement sash without casings. The façade (south elevation) contains a full-length, one-story projection with a low hip roof. The enclosed eastern third of this projection has a pair of casement windows. An open porch occupies the western portion of the projection, comprised of square posts and a railing of modern turned balusters. A shallow pedimented portico is centered on the building, on axis with a single-leaf door on the main block. To the right of this entrance is a small octagonal window. Offset on the westernmost bay of the façade is another single leaf door with half height sidelights and a small octagonal window to its left. A shallow rectangular projection is centered on the second floor of the main block, containing two small 6/1 windows. The outer bays of the second floor each contain a single window. A long, low, hip-roofed dormer is centered in the half story, with three asymmetrical windows.

The east (right side) elevation contains a triplet of casement windows near the front of the first floor, two windows of varied size on the second, and a high hip-roofed dormer with two 1/1 windows in the half story. A one-story appendage with a hip roof extends along the northern half of this elevation, with a single-leaf door centered in the wall facing the street and a small wood stairway with wood railings. The irregular west (left side) elevation of the main block contains 1/1 windows of various sizes.

Although well maintained, 17 Holland Street has lost considerable historic integrity through the application of vinyl siding, loss of original trim, altered fenestration, replacement sash, and replaced porch elements. The house is notable for its substantial size and scale, picturesque roof edge, and manipulations of the wall planes.

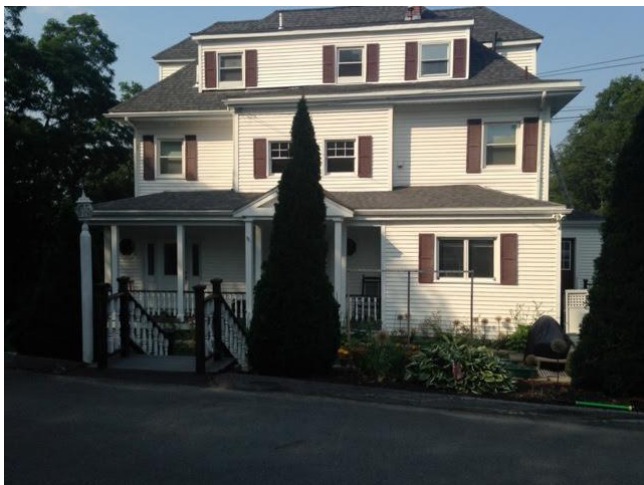
South (façade) elevation
