FIRST PERIOD SURVEY

Town Lexington

Address 1303 Massachusetts Ave.

Historic Name John Mason House

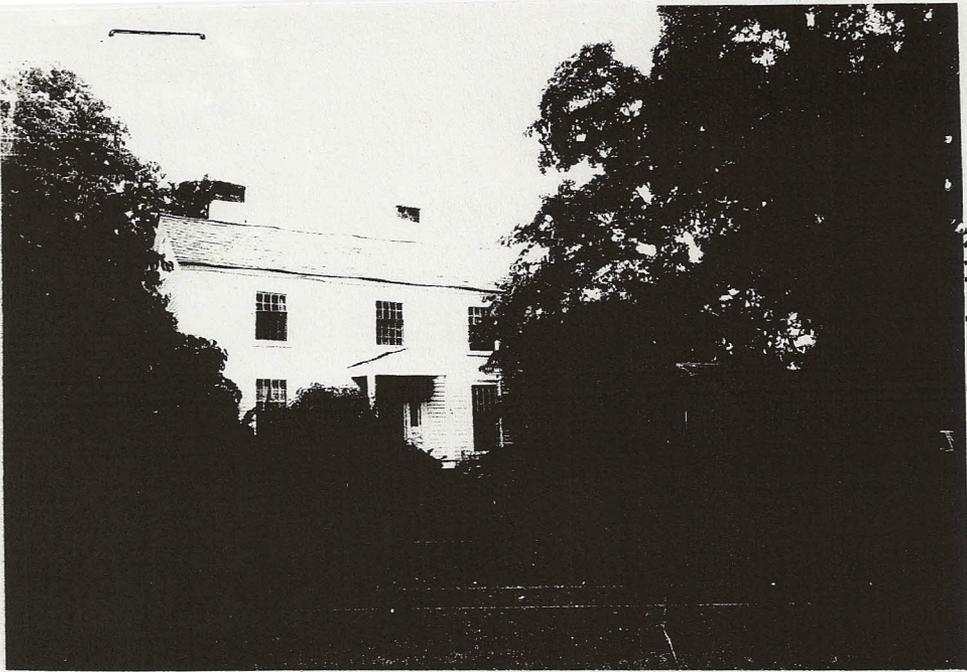
- 13:3 east chamber
- 13:7 detail, summer beam and end girt, west chamber
- 13:9 south facade
- 14:26 attic

Evidence of First Period construction is found in the southeast room and in the southeast and southwest chambers.

In the southeast room, only the east end girt is exposed. It has an inch-wide quirked bead.
