FORM B – BUILDING

Town: Lexington

Address: 15 Audubon Road

LEXINGTON

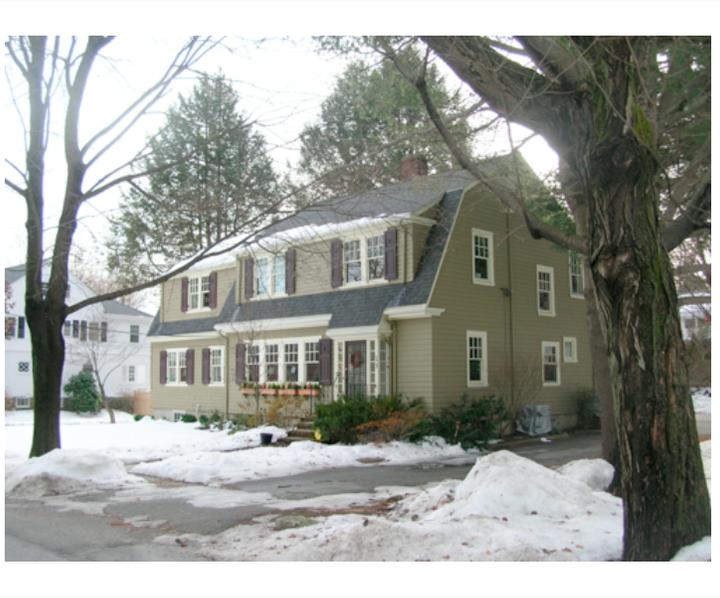
Photograph

Doubled in size by a recent but sympathetic addition at its south end, 15 Audubon Road is a good example of the Dutch Colonial style. Characteristic of the style, the two-story house displays a side gambrel form with a full-width shed dormer. It rests on a mortared stone foundation and is sheathed in wood shingles with an asphalt-shingled roof and a brick chimney rising from the rear slope. The offcenter entrance is marked by a single-bay glazed vestibule which is sheltered by a shed extension of the front roof slope. Adjacent to the entrance is a set of four 6/1 windows with blinds. Upstairs, punctuating the shed dormer are two pairs of 6/1 windows. The north end of the building features a mix of 6/1 windows and a single-story rear addition is a single bay deep.

The front wall of the 2007 addition to the south is set back slightly from the façade of the original building. Its massing, sheathing, roof and windows are all imitative of the original although it is set on a poured concrete foundation. Originally a much smaller, single-story, flat-roofed sunporch spanned the south side of the house.
