# FORM B – BUILDING

**Town/City:**    Lexington

**Address:**            346 Concord Avenue

**Style/Form:**            Bungalow

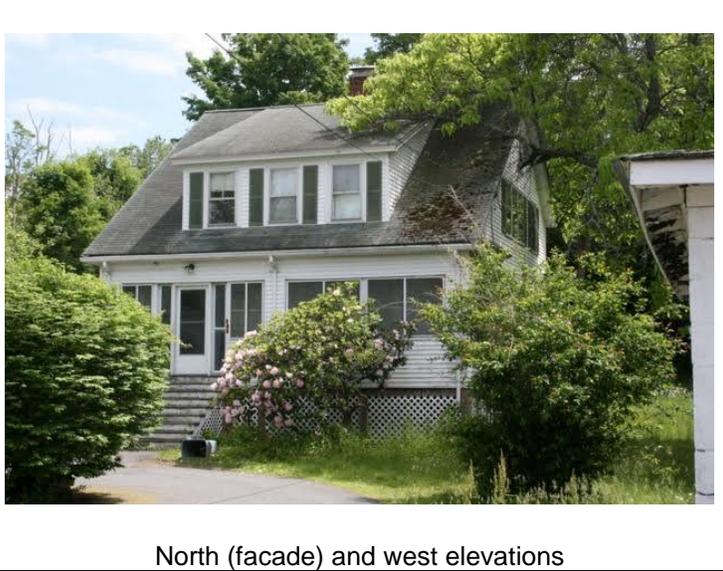
North (facade) and west elevations

The rectangular volume of the house rises 1 ½ stories (plus an attic) above a fieldstone foundation and raised basement. The asymmetrical side-gabled roof has gable returns at the front corners; the front slope extends over what was originally a full-length front porch. Walls are presently clad with artificial siding and trim. Visible sash is typically double-hung; fenestration on the front and sides of the enclosed front porch may be fixed. One chimney is centered at the ridgeline.

The façade (north) elevation comprises two bays on the first floor, with modern windows in the west bay and an offset entrance in the east bay. A wood stairway with a simple, modern metal railing accesses the doorway; the door itself is not visible from the street. A wide shed dormer above contains three 2/1 windows. The asymmetrical west elevation has grouped windows on the first and half- stories, a shallow rectangular bay window with a shed roof projecting from the first floor, a small attic window centered in the gable peak, and two large basement windows. On the asymmetrical east elevation, a small side entrance is accented by a shed-roofed porch with square posts set on low walls, and what appear to be stone steps. The irregular fenestration on this elevation again culminates in a small attic window centered in the gable peak.

The modest buildings at 346 Concord Avenue are in fair condition, and the house has lost historic integrity by the application of artificial siding, the removal of original wall and window trim, and the unsympathetic enclosure of the front porch. The property is notable, however, for its survival in an area of much later development, with its large lot, characteristic Bungalow form, and early garage intact.

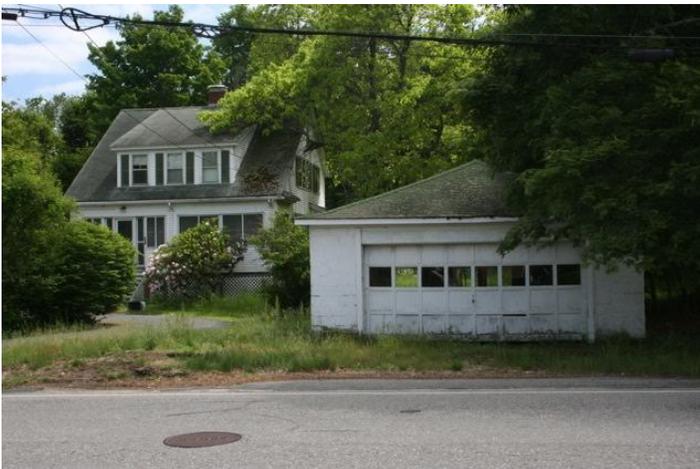
North (facade) elevations of house and garage

A painted concrete block garage stands at the northwest corner of the lot, close to the street. The rectangular structure features a hip roof with exposed rafter ends; a nearly full-length, wood and glass paneled door on the street façade; and a pair of horizontal, three-light windows set high on each of its side (east and west) elevations.

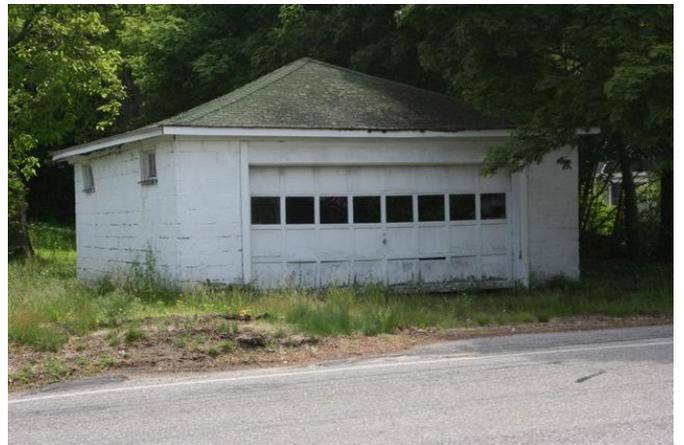
Garage: East and north (facade) elevation
