# FORM B – BUILDING

**Address:** 416 Concord Avenue

**Recorded by:** Wendy Frontiero

416 CONCORD AVE.

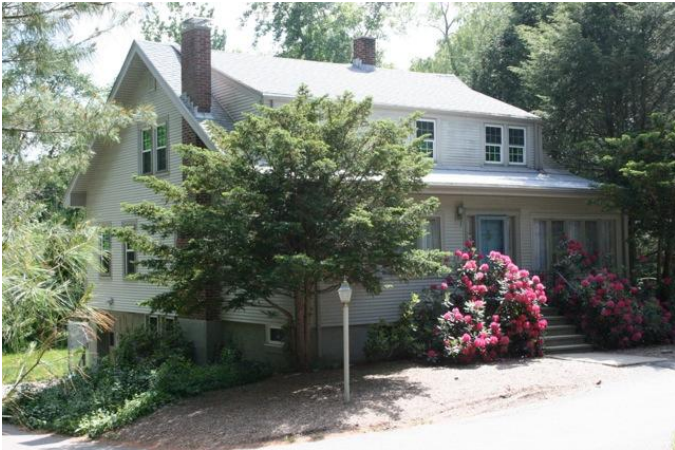
Left side and front (facade) elevations

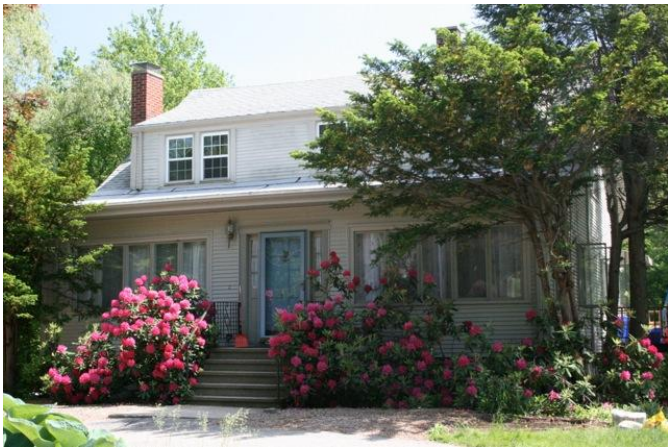
The façade (north) elevation contains a Colonial Revival center entrance with a panelled wood door, narrow reeded pilasters, half-height sidelights, and a concrete stairway. Bands of casement windows flank the doorway on the first floor. Above, a nearly full-length shed dormer contains a single center window flanked by paired windows, all double-hung.

Front (facade) elevation

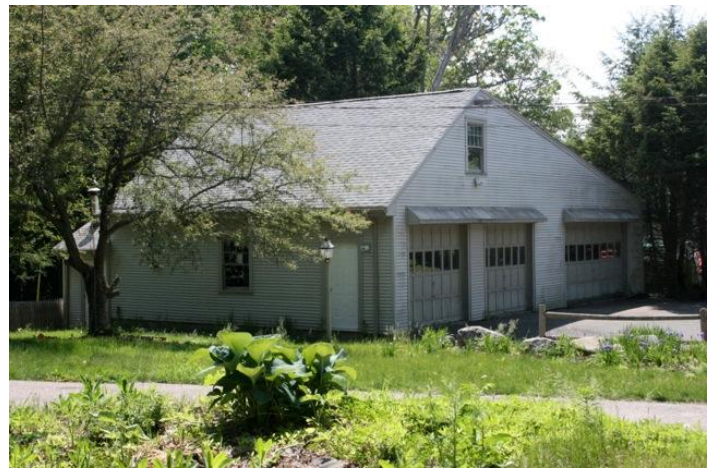
A large, front-gable garage with three vehicle bays is located to the west of the house, with a similar setback from the street and a wide paved surface in front. The garage has a poured concrete foundation and artificial siding and trim. On its façade (north) elevation, the structure's asymmetrical gable-end encompasses two individual bays on the east and a wider opening on the west. All three openings have shallow shed-roofed hoods and wood and glass paneled doors. A small 8/1 replacement window is offset in the gable peak, surmounted by a very small hoisting beam. Side elevations of the garage each have an original or early 8/1 double-hung wood sash centered on the wall. The east elevation, facing the house, also has two modern doorways: one toward the front of the wall and the other in a small pitched-roof addition at the rear of the main block.

Garage: Left side and front (facade) elevations
