# FORM B – BUILDING

**Town/City:** Lexington

**Address:** 12 Crescent Hill Avenue

12 CRESCENT HILL AVE.

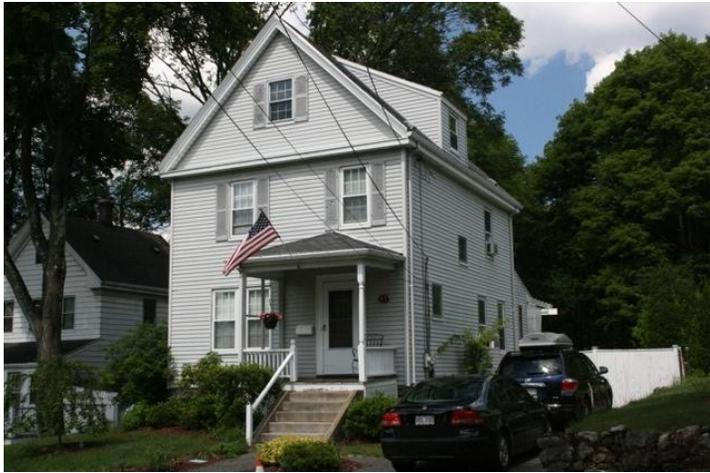
Front (facade) and right side elevations.

The roughly L-shaped main block of the house rises 2 ½ stories from a fieldstone foundation to a front gable roof. A one-bay deep appendage with a shed roof extends across the back (east) of the building. One interior chimney rises from the left slope of the main roof, near the center. Walls are clad with artificial siding and trim. Windows are typically 6/6 double hung replacement sash, without trim. The asymmetrical façade (west) elevation contains an offset entrance and paired windows on the first floor and two individual windows asymmetrically set on the second floor, and one window centered in the pedimented half-story. The front entrance is composed of a rectangular porch with a hip roof, turned posts, a low wood railing with thick square balusters, concrete steps, and a single-leaf, period door with wood panels and one large, square glass pane.

The left (north) side elevation contains one window bay on the main block. A two-story hip roof ell at the back has one 6/6 window facing the street at the second story, and modern awning windows with transoms at the corner of the first floor. The irregular right (south) elevation has three windows on the first floor, one at an intermediate level, and one towards the back of the second floor. A small shed-roofed dormer on this elevation has a one window. The shed-roofed addition has one window at each of its ends.

Well-maintained, 12 Crescent Hill Avenue has lost important original trim but remains a good example of turn of the 20<sup>th</sup> century suburban middle class housing. It is notable for its pedimented front-gable façade, ornamental entrance porch, distinctive vertical massing, and relatively large scale in a subdivision of mostly smaller and more compact houses.

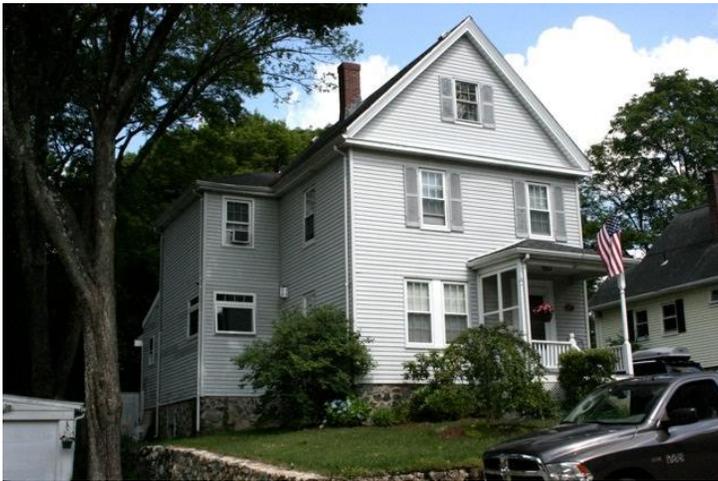
Left side and front (facade) elevations
