FORM B – BUILDING

Town/City: Lexington

Address: 198 East Street

Date (*month / year*): September 2015

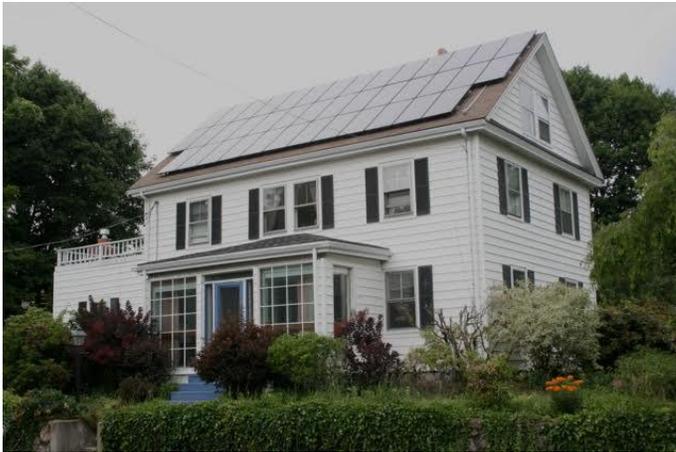
Front (facade) and right side elevations

The three by two bay main block rises from a fieldstone foundation to a side gable roof. Walls are clad with artificial siding and trim. Windows typically have 2/1, possibly original or early double-hung sash with no trim. A hip roofed enclosed porch is centered on the façade, with modern casement and picture windows and a wood stairway, and narrow sidelights on its single leaf door. A pair of windows is centered above. The outer bays of the façade have a single window, vertically aligned, on each floor. The gable ends are pedimented on both of the side elevations. The right side elevation is symmetrical, with two windows on each of the lower floors and paired windows in the attic story. The left side elevation contains a one-story side extension with one window centered in the façade, an exterior chimney on its left side elevation that is centered between two narrow windows, and a flat roof with a modern roof deck. Two symmetrical single windows occur on the second story, and paired windows are centered in the attic story. The rear elevation is not clearly visible from the street, but includes a small one-story addition at the left corner and a two-story ell near the middle.

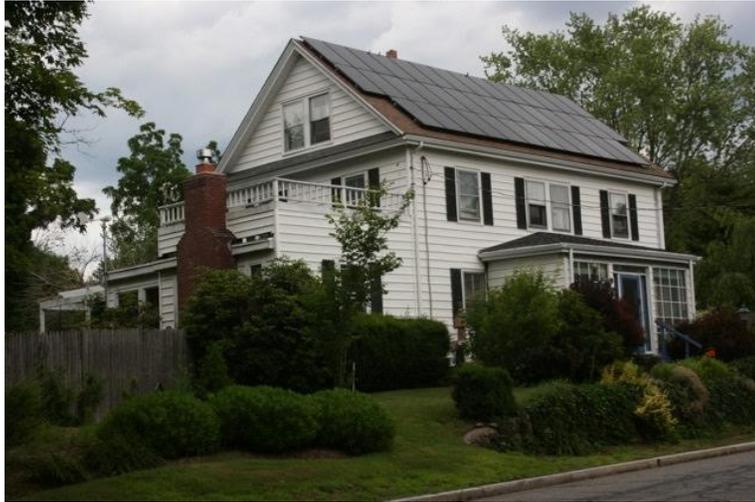
Left side and front (facade) elevations

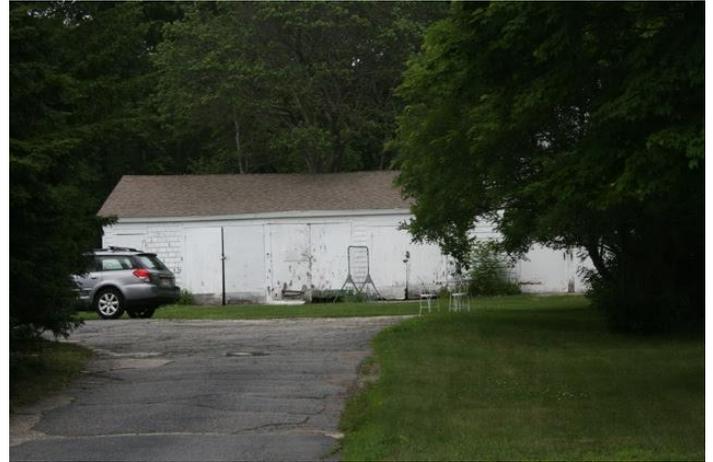
Barn 1: South (facade) elevation

Two early outbuildings stand behind the house. Near the back corner of the house and the west property line is a small shed/barn structure with a shed roof. Clad in wood shingles, the façade of this structure has irregular fenestration, including a large offset opening that has been turned into a glazed entrance bay. Near the back (north) property line is a long, one-story barn structure with a low side gable roof, three pairs of plain double-leaf barn doors, and one pedestrian door at the left end. A 1 ½ story, cross-gabled bay anchors the right end of the structure, on which are centered a pair of large, double-leaf barn doors. This structure is clad with wood shingles and wood trim; no gable returns visible.

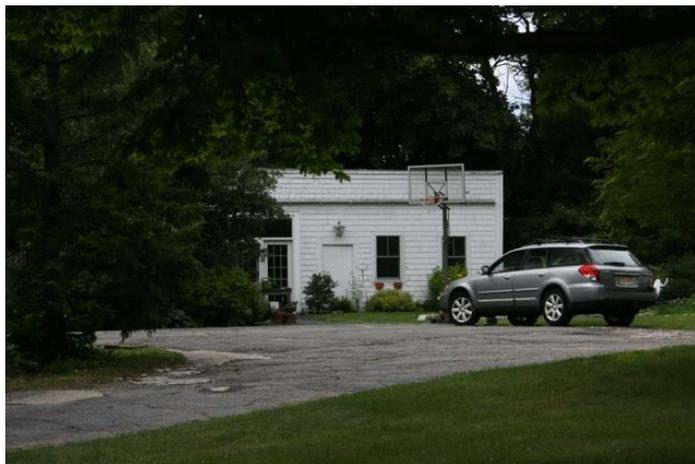
Barn 2: East elevation
