INVENTORY FORM B CONTINUATION SHEET

LEXINGTON

4 HAYWARD AVENUE

MASSACHUSETTS HISTORICAL COMMISSION

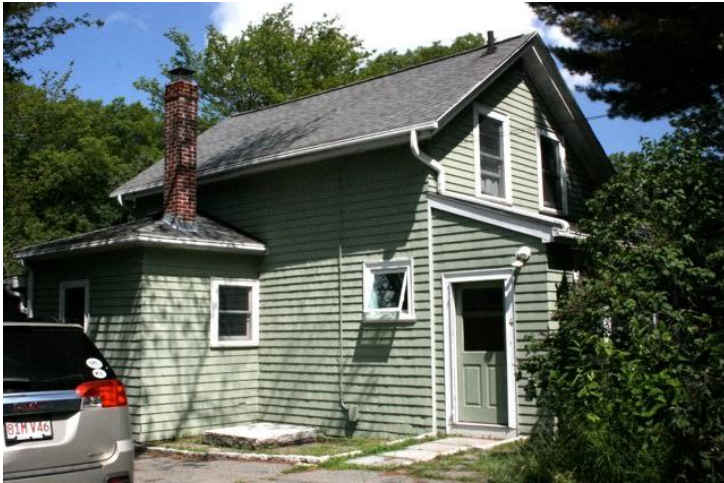
Left side and front (façade) elevations

4 Hayward Avenue is set at the front of a small, narrow lot with minimal front and side setbacks. The land slopes down steeply away from the street behind the flat front yard. A broad paved driveway occupies most of the left side setback, with a paved stone walk leading from it to the front entrance. The building consists of a 1 ½ story main block with front, side, and rear appendages.

The small, rectangular main block rises from a fieldstone foundation with deeply recessed joints to a front gable roof with no gable returns and no chimney. Walls are clad with wood shingles and have a narrow flat fascia board with a small bed molding. Windows typically have 1/1 double-hung replacement sash with very narrow band molding. The front façade of the main block has a full-length enclosed porch with a door on its short left side, four contiguous windows along the front, and a narrow horizontal window on the right side. Inside, on the main block, are an offset door and single window. Two windows are symmetrically placed in the half story.
