FORM B – BUILDING

Town/City: Lexington

Address: 10 Independence Avenue

Historic Name: Larkin Smith House

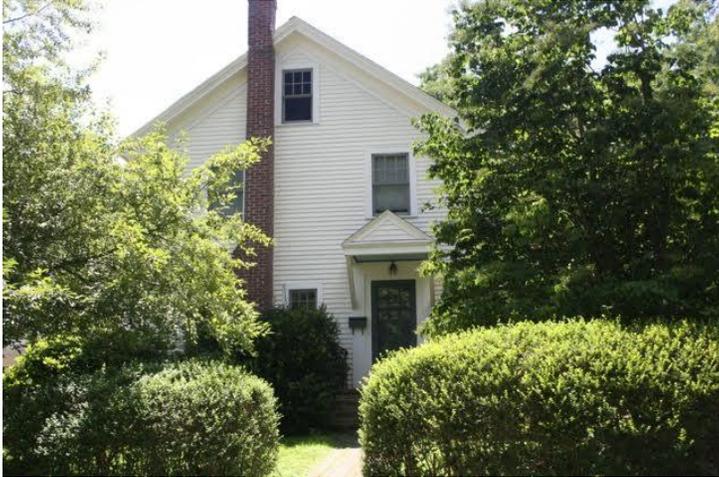
The main block rises 2 ½ stories from a granite rubble foundation to a low-pitched, front gable roof with narrow gable returns. An exterior chimney climbs the front façade of the main block; an interior chimney is situated near the center of the left slope of the main block. Walls are sheathed with wood clapboards and are trimmed with plain flat corner boards and a flat fascia with a narrow crown molding. Windows are typically 6/1 double-hung replacement sash with flat casings. The façade contains an offset entrance with a modest gabled hood supported on plain braces. Wide flat trim surrounds the single-leaf door, which has vertical wood panels and 3 by 3 glass panes above. The door is accessed by a poured concrete stairway with brick treads. A small window is set between the doorway and exterior chimney on the first floor. Two widely spaced windows are symmetrically positioned on the second floor, and a smaller window is centered above in the half story.

Front façade of main block

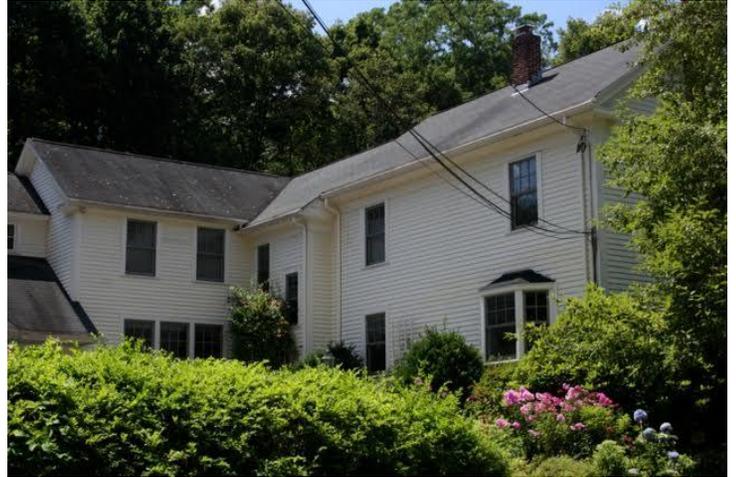
The left side elevation of the main block has two widely spaced window bays with one window and a small angled bay window at the first floor and two windows on the second floor. The right side elevation is not easily visible from the street. Observed were a pair of fixed, multi-light windows towards the front on the first floor and a picture windows towards the back of the first floor, on the rear extension.

A short stairway addition at the back left corner of the main block connects to a perpendicular, two-story wing with a side gable roof. The façade of this wing has a trio of tall windows on the first floor and two individual windows on the second floor. Projecting from the end of this wing is a 1 ½ story entry bay with a high gable roof and single-leaf doorway at grade. This sequence of additions is completed by an attached garage that twists at an angle around the parking area/driveway. The garage has a side gable roof with a saltbox form at the rear, a cross-gabled dormer, and two vehicle bays.

Rear all and left side elevation of main block

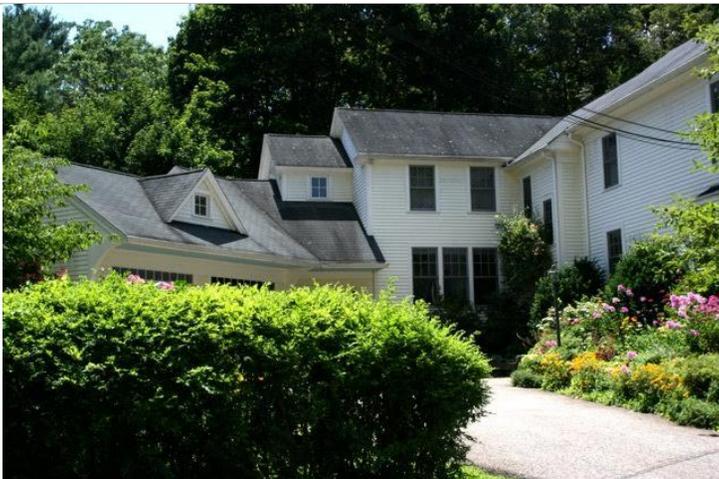
Garage and rear additions

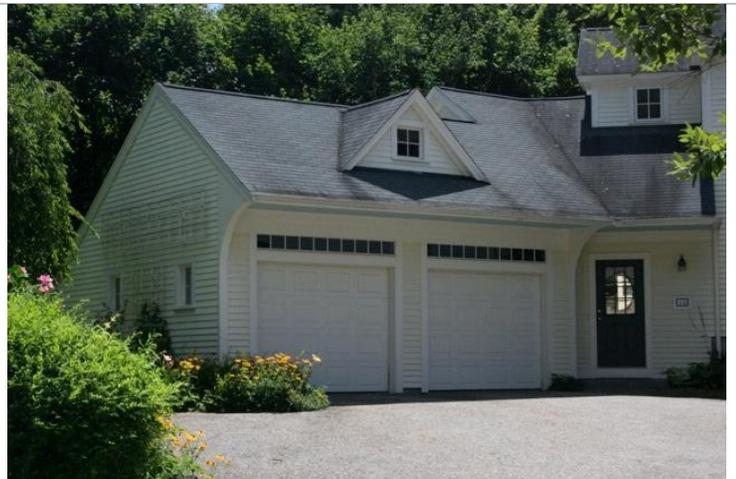
Front façade of garage addition
