# FORM B – BUILDING

**Town/City:** Lexington

**Address:** 11 Lowell Street

**Date of Construction:** ca. 1890-98

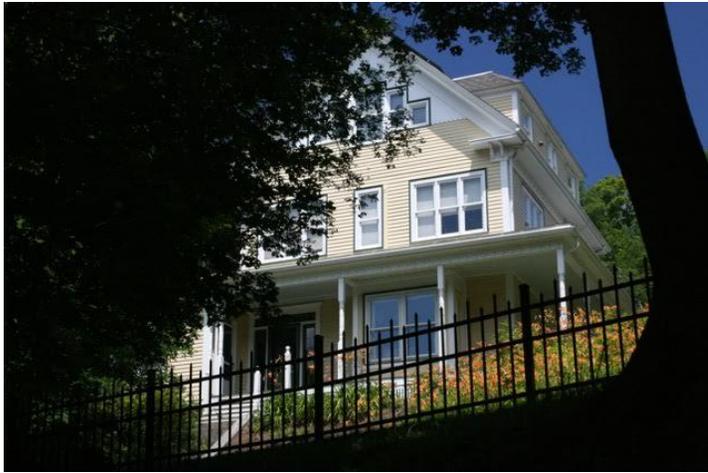
West (facade) and south elevations

On the façade (west) elevation of the main block, an offset entrance under the porch has a single leaf door, full height sidelights, a rectangular transom, and modest pilasters and entablature. It is flanked by a rectangular bay window with diamond-shaped appliqué on its fascia. Upper floors of the façade contains a narrow center window flanked by a trio of windows on each side of the second floor and, in the half-story, an elaborate Palladian window unit with five window sash of varied sizes and sill and head heights. Its large center sash has a semi-circular glazed transom.

The right (south) side elevation has one single window and a small angled bay on the first floor, under the porch roof. One pair and one triplet of windows are asymmetrically set on the second floor, while a long shed dormer with a hip roof is lit by a pair of windows flanked by a single window on each side. The rear of the main block contains a single window on the first floor, paired windows on the second floor, and a single window centered in the gable peak. The lower rear ell has a ridgeline parallel to the main roof, with a saltbox shape, offset single leaf door, and overhanging second story with a Palladian-motif window motif composed of three non-contiguous rectangular windows.

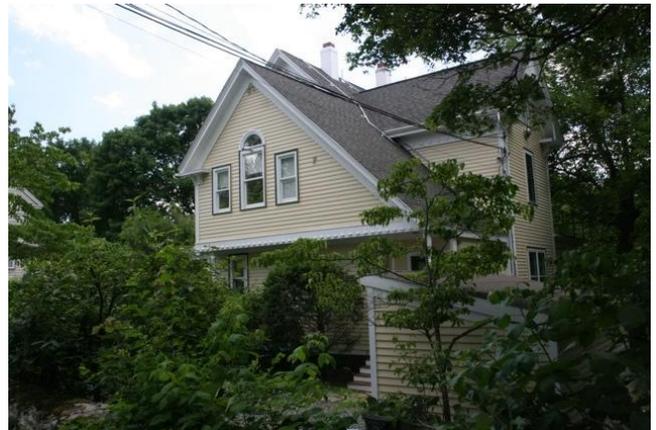
East and north elevations

The cross-gabled ell on the north side rises the same 2 ½ story height as the main block; only one bay wide, it has paired windows centered on the first floor and a single window centered on the second and half-stories above. A one-story, flat roofed appendage fills the northwest corner between the façade (west) elevation of the main block and the cross-gabled side ell. Extending the line of the front porch, it is detailed with trim and windows similar to the main block.

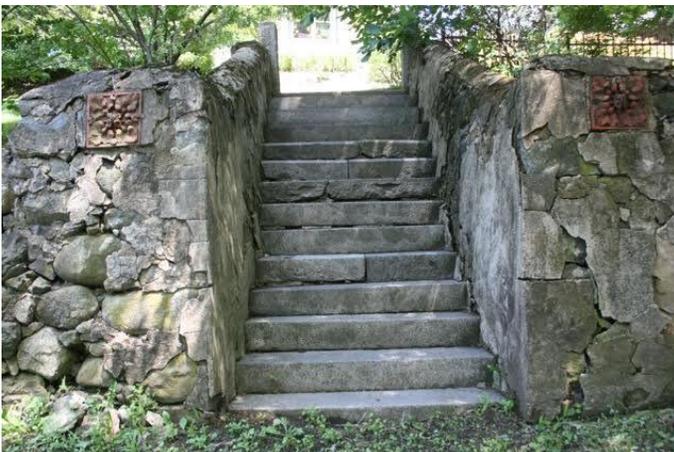
Landscape detail: Retaining wall and steps at Lowell Street

11 Lowell Street occupies a large, steep, hillside property that extends between Lowell Street on the west and Westminster Avenue on the east. The property is bounded by a substantial stone retaining wall at the Lowell Street edge, with remnants of parking, and two flights of cut granite steps up to the main entrance. The steep front yard is terraced and maintained in lawn and perennial beds; a line of large trees occupies the lower terrace, along with a modern metal picket fence. Along the Westminster Avenue frontage is a fieldstone wall; dressed granite posts with chiseled margins frame openings for a walkway and a large, L-shaped driveway.

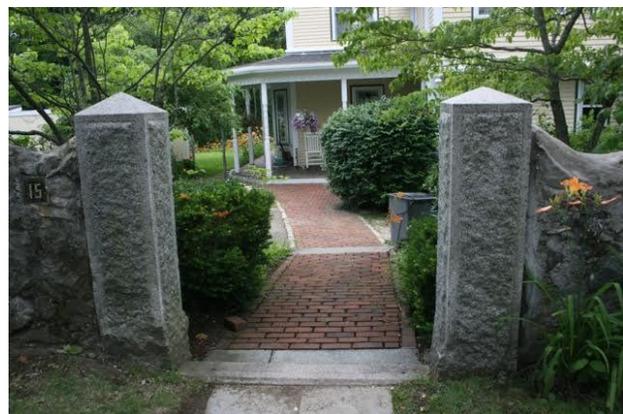
Landscape detail: Stone wall and posts on Westminster Ave.

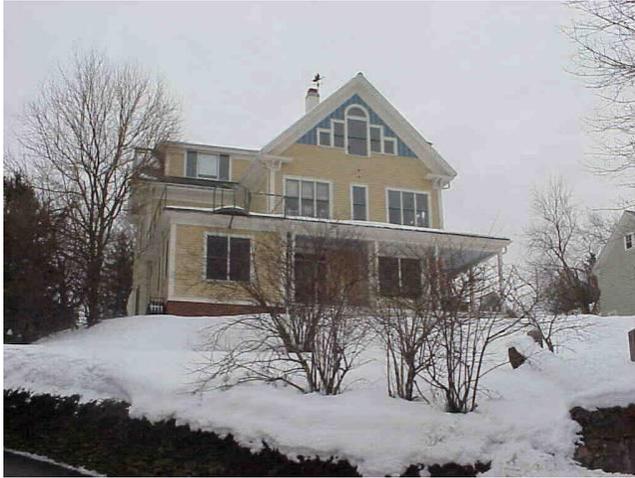
Assessors' photograph: West (facade) elevation
