FORM B – BUILDING

Town/City: Lexington

Address: 519 Lowell Street

Recorded by: Wendy Frontiero

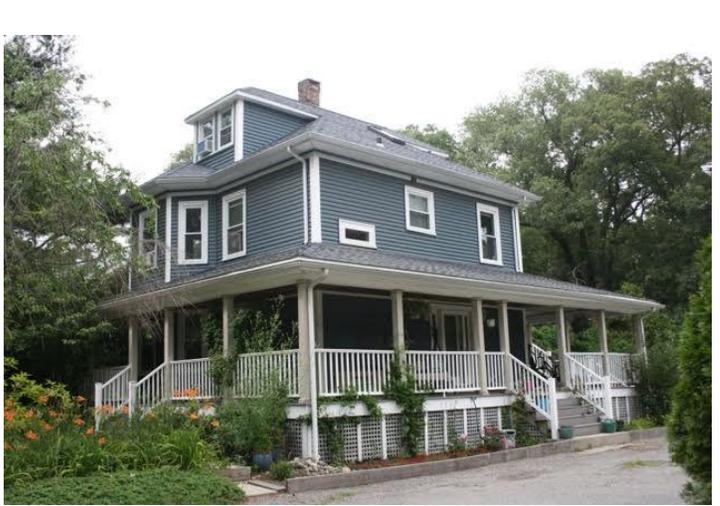
Photograph

West (facade) and south elevations

The house rises 2 ½ stories from a raised basement with a fieldstone foundation to a high hip roof with high hip roofed dormers centered on the front and back elevations and one interior chimney. Walls are sheathed with artificial siding and trim. Windows typically have 1/1 double hung replacement sash with vinyl trim. The asymmetrical façade contains an offset, two story angled bay window with a single window on each face at both floors and a modern, single-leaf door near the center of the façade that is surmounted by a single window on the second story. A hip-roofed porch with Tuscan posts extends across the front and right side elevations. It has modern wood railings with square balusters and wood stairways on both elevations. (Assessor's photos show that the façade previously had an enclosed, hip roofed sun porch only across the flat part of the façade, south of the bay window.)

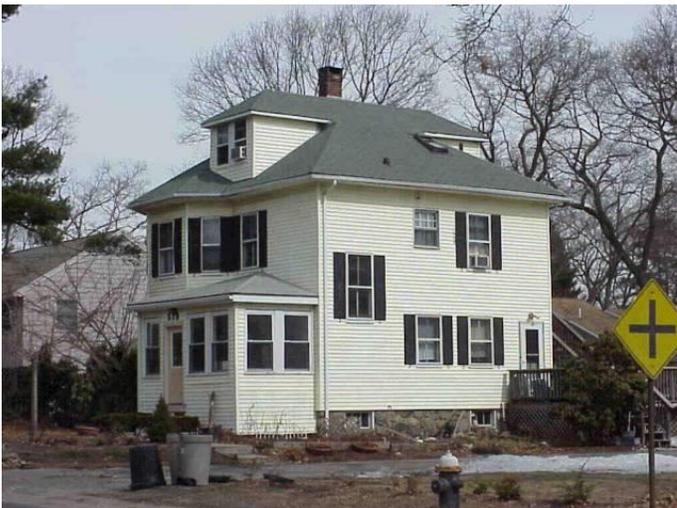
SUPPLEMENTARY IMAGES

The right (south) side elevation has asymmetrical fenestration, with three irregularly sized and placed windows on the second floor and a slightly off-center doorway with full height sidelights. (Assessor's photos show this elevation without a porch, and with two windows and an offset door at the first floor, and other fenestration on the second floor.) The left (north) side elevation has two widely spaced, vertically aligned windows on each floor. An exterior wood stairway and second floor deck are partially visible on the rear elevation.

Assessors photograph: West (façade) and south elevations
