FORM B - BUILDING

AREA	FORM NO.
	587

Address 419 Marrett Road

Historic Name Joseph Bridge House

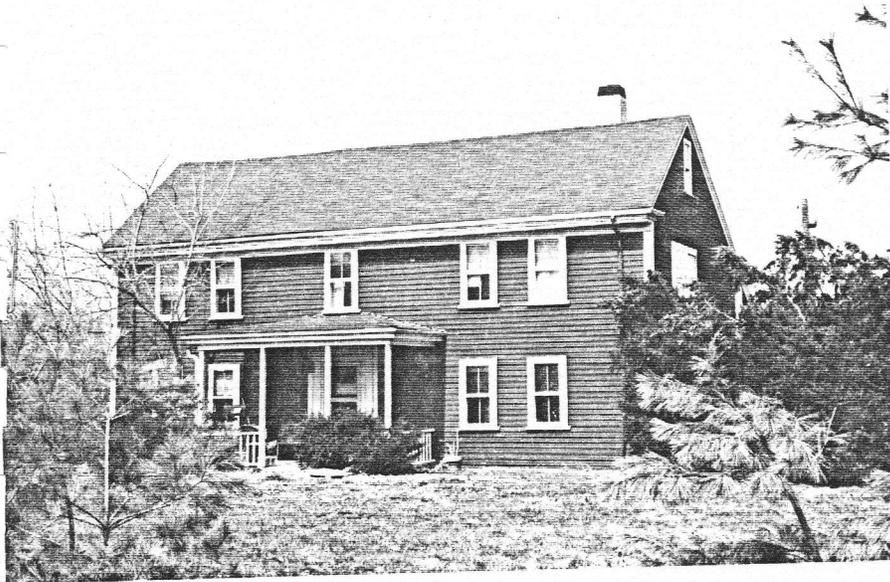
This is one of two early Second Period houses in Lexington which retain an integral lean-to in its original configuration (the Whittemore Muzzey house on Marrett Street in Minute Man Park is the other). Second Period Vernacular features include small narrow windows placed with the outermost two grouped closer together, clapboards with narrow weather, and panelled pilasters at the entry (an added porch has obliterated the entablature over the door visible in an early photograph). There is evidently raised-field panelling in several locations on the interior.

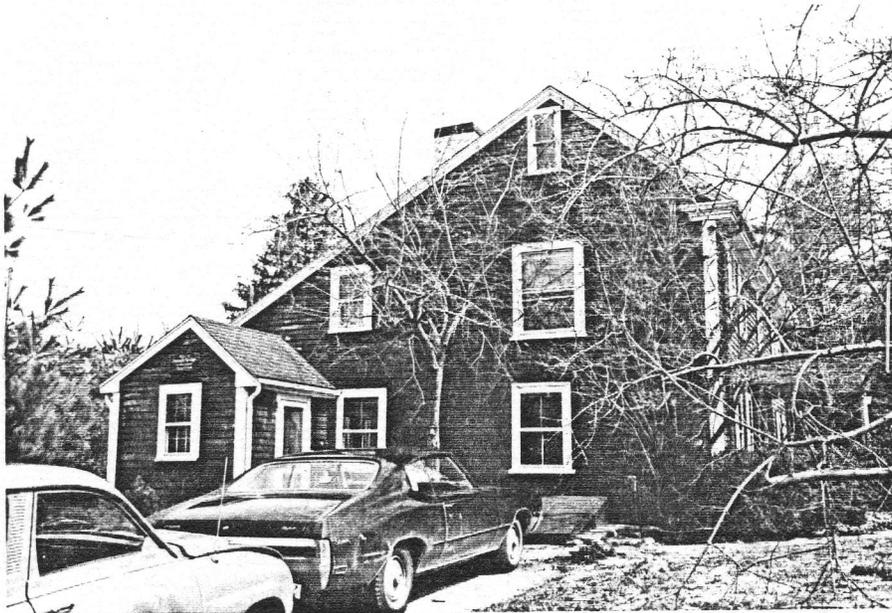
For some reason (perhaps a fire) a four-bay-wide, one-room-deep addition to the right visible in the early photograph (Kelley 1980:14) has been removed.
