FORM B – BUILDING

Town/City: Lexington

Address: 144 Marrett Road

Recorded by: Wendy Frontiero

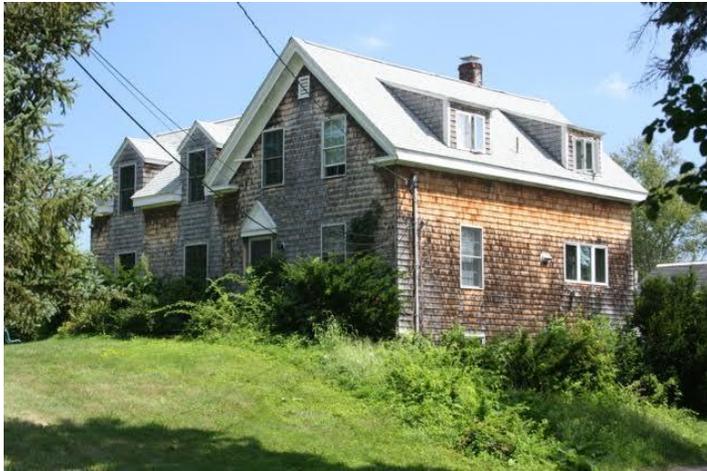
Façade (northwest) and right side (southwest) elevation

The rectangular main block rises 1 ½ stories to a front gable roof with gable returns and a chimney on the left slope, near the ridge line. Walls are clad with wood shingles and trimmed with bed molding at the eaves. Windows typically have 6/6 double-hung replacement sash and no trim. The façade (facing northwesterly) has an offset entrance and one window to the side on the first floor, and two windows centered above in the half story. The single-leaf door is framed with a flat casing and a high triangular “pediment” with a flat center and perimeter molding. A 1 ½ story addition on the left (northeast) side of the main block has a side gable roof and two windows on each floor; the upper windows are contained in flush-wall dormers with gable roofs (no returns).

The right side (southwest) elevation of the main block contains one double-hung window toward the front and a triple-casement unit towards the back of the first floor. Symmetrically placed on the roof, two shed-roofed dormers each have a pair of casement windows. The partially exposed basement on this elevation has utilitarian fenestration. The rear (southeast) elevation of the main block has a single-leaf door centered between two windows on the first floor, and two windows centered in the half story above. A one-story extension to the east has another single window. A modern wood deck spans the back elevation, with square vertical balusters on its railings and wood steps.

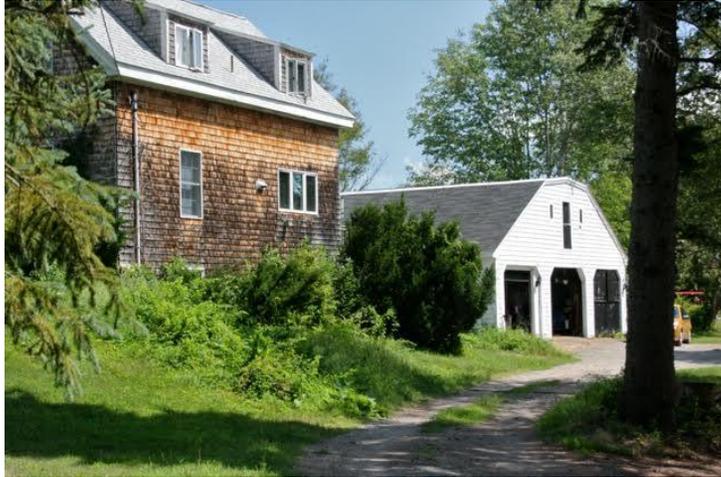
Southwest elevations: House and barn

Located directly behind the house is a large barn (nearly 1000 square feet) with a broad, front-gambrel roof and three vehicle bays. One tall window is centered in its half story, flanked by two very small vertical openings. The barn is clad in wood shingles and has plain flat wood trim.

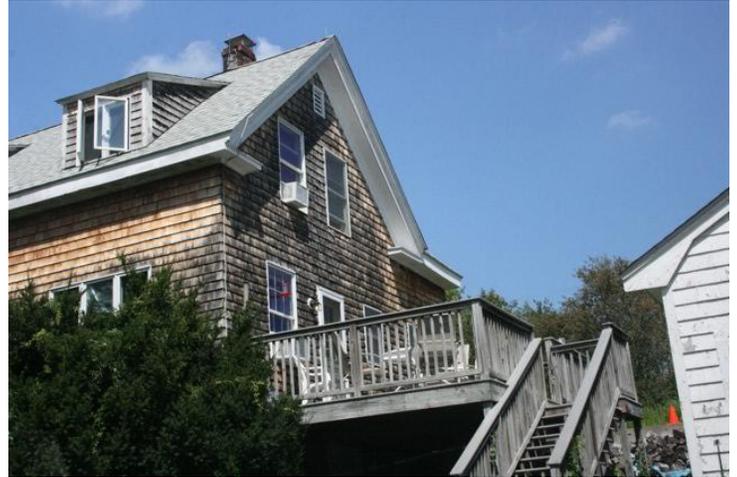
Rear (southeast) elevation

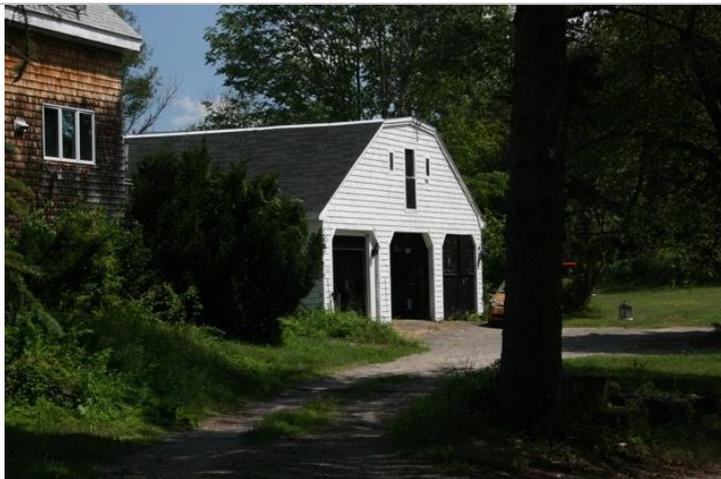
Barn: Southwest (façade) elevation
