# FORM B – BUILDING

**Town/City:** Lexington

**Address:** 16 Middle Street

**Recorded by:** Wendy Frontiero

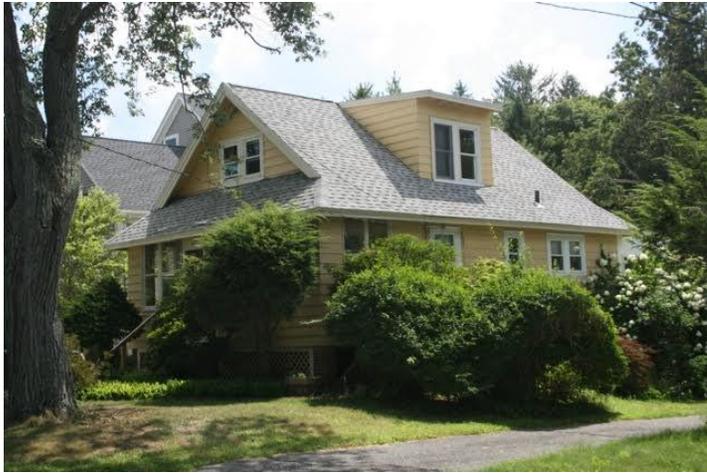
Front (façade) and right side elevations

The small main block rises from a poured concrete foundation with rubble above to a front gable roof with exposed rafter ends. A wide roof skirt across the front forms a pediment and encloses a sun porch. The porch is supported on brick piers and accessed by poured concrete steps. Walls are sheathed with aluminum siding. Windows typically have 1/1 double-hung replacement sash with narrow band molding. The front façade has paired windows and an off-center, single leaf door with narrow sidelights. Inside on the main block facade, an off-center single-leaf door has paired windows to the right and a single window on the left. Small paired windows are centered in the half story of the main block.

The left side elevation has paired windows at the side of the sun porch and, on the main block, two single windows of varied sizes and a set of paired windows towards the back. A tall, shed-roofed dormer has exposed rafter ends and no visible windows. The right side elevation has paired windows at the side of the sun porch, three single windows on the main block (including a shorter one in the middle), and a high, shed-roofed dormer with exposed rafter ends and paired windows on its front face. A small rear addition at the back right corner of the main block contains one story under a shed roof. Two pairs of windows (possibly casements or sliders) occupy its right side elevation, which appears to be sheathed in plywood to the sides and above the windows and wood panels below.

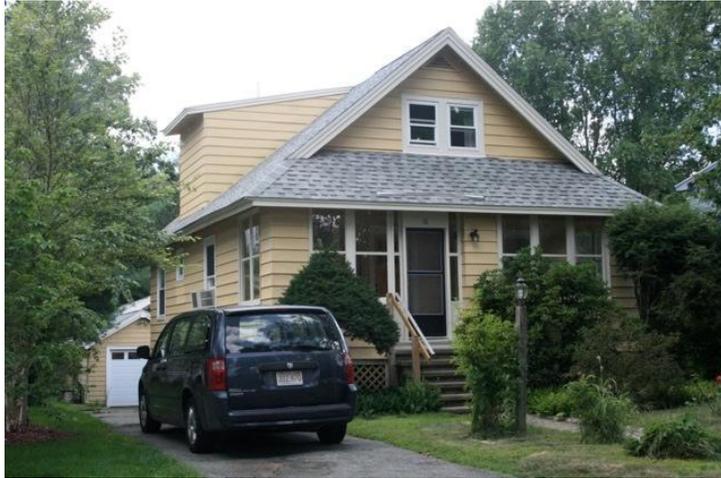
Left side and front (façade) elevations

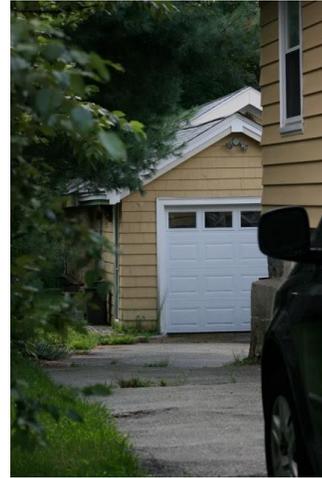
Garage: front (façade) elevation

A free-standing garage stands behind and to the left of the house. The small original structure has a front gable roof without returns and one vehicle bay within its wood shingled walls. A significant addition behind the garage and projecting to the right of it is also one story high. Its right side elevation contains a single-leaf pedestrian door and a picture window unit.

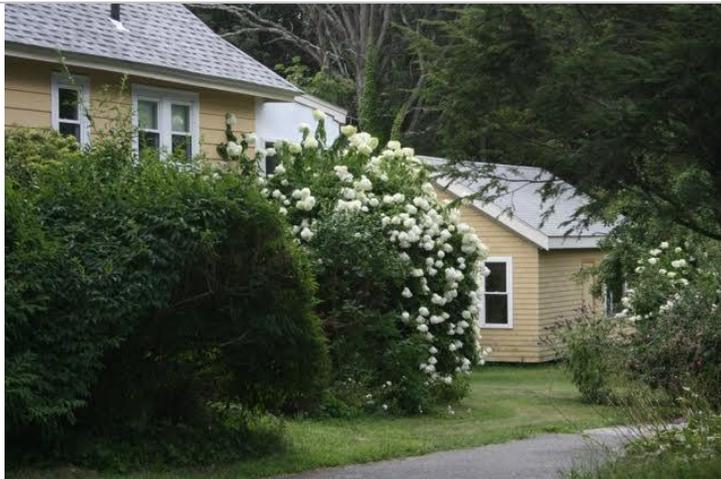
Garage addition: front (façade) and right side elevations
