FORM B - BUILDING

Organization: Lexington Historical Commission

Town/City: Lexington

Address: 10 Oakland Street

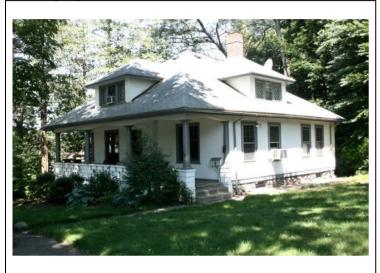
Photograph

Front (facade) and right side elevations

The approximately square building rises 1½ stories above a fully-exposed basement on the left side to a hip roof with deep eaves and a hip-roofed dormer centered on each slope. One chimney rises above the right slope. Walls are stucco with wood sill boards. Trimmed with wood band molding, windows have 6/1 (on the left side) and 9/1 (on the right side) double hung sash, with diamond-paned sash common in grouped windows. The three-bay façade has an 8/1 window on each side of a shallow center entrance vestibule, which features angled corners and a period door with wood and glass panels. Recessed below the front slope of the roof, a full-length porch has a solid concrete foundation and semi-open half-walls of faux-stone concrete blocks, surmounted by sturdy Tuscan columns and a shaped stucco fascia.

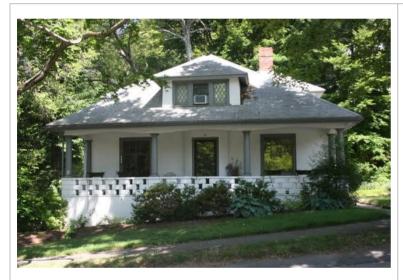
Front (facade) elevation
