FORM B – BUILDING

Town/City: Lexington

Address: 2 Oakmont Circle

Style/Form: Colonial Revival Cape

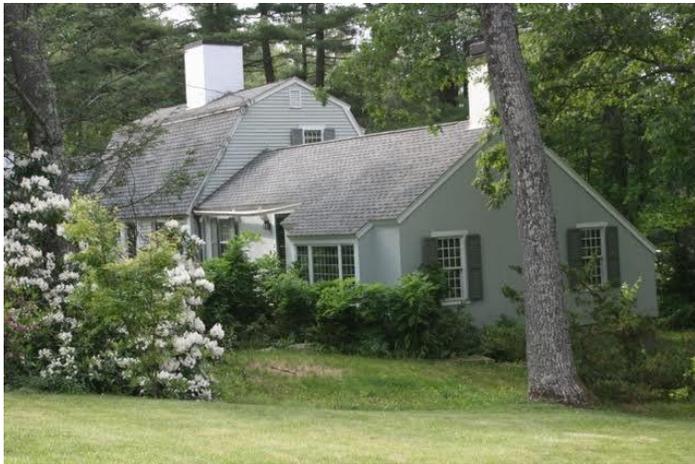
Photograph

Front (facade) and right side elevations

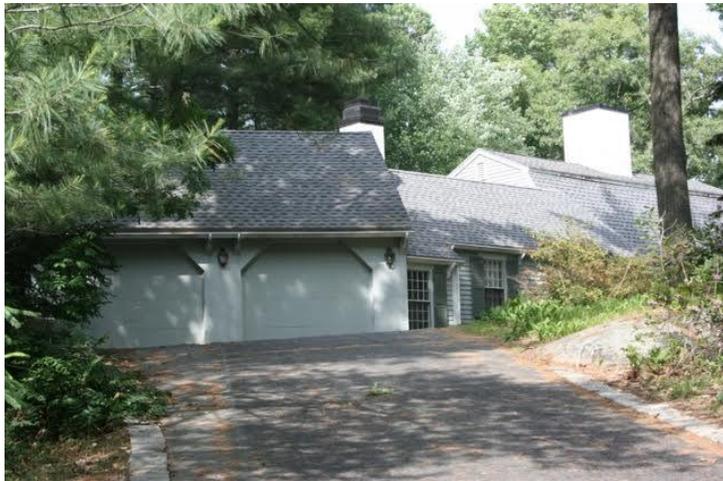
The attached garage has two vehicle bays with solid wood doors, a side gable roof, and simple sawn brackets at the roof eaves. Its exposed gable end has a single 12/12 window centered on the main floor; the rear elevation contains an offset doorway with plain flat casing.

Garage and wing: Front (facade) elevations
