FORM B – BUILDING

Town/City: Lexington

Address: 32 Rindge Avenue

32 RINDGE AVENUE

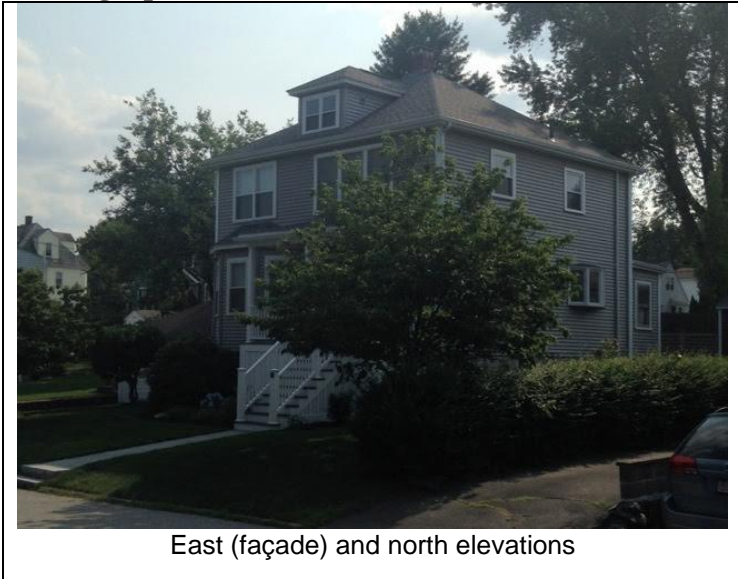
Photograph

32 Rindge Avenue occupies a small lot that slopes up slightly from the street. The house is positioned near the back right corner of the property, with a detached garage to the left. The front and side yards are maintained chiefly in lawn, with foundation plantings around the house. A broad driveway lined with concrete pavers leads from the street to the garage and is bordered by a low stone retaining wall enclosing the corner of the front yard. A stone-paved walkway extends from the street to the front entrance. The house consists of a 2 ½ story, nearly square main block and a low rear addition.

The two by two bay main block rises 2 1/2 stories from a concrete foundation to a hip roof with a center chimney. Walls are sheathed with vinyl and vinyl trim. Windows typically have 1/1 double hung sash. The front façade (east elevation) contains an angled bay window and wide entrance porch on the first floor, surmounted by paired windows over the bay window and a triplet of windows centered above the porch. Due to the slope of the yard, the basement is partially exposed at the front of the house, with a long flight of wood steps leading to the front entry porch. Thin square posts support the porch's low hip roof, and vinyl railings span the posts. The single-leaf doorway is offset to the right of a set of paired windows underneath the porch. The half story dormer is centered on the front slope of the main roof and contains paired 1/1 windows.

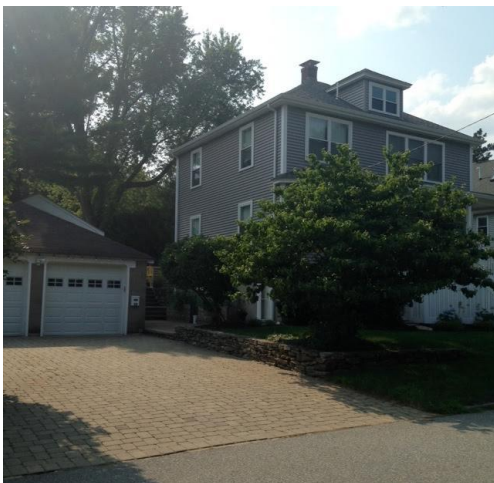
The north (right side) elevation contains three small awning windows at the basement level, three small symmetrically placed, 1/1 windows on the first and second floors, and a small modern bow window on the first floor. A narrow, 1-story extension spans half of the rear elevation of the main block, displaying a very shallow-pitched shed roof and one window on its right side. The south (left side) elevation of the main block contains two widely spaced window bays with a single window on each story.

South and east (façade) elevations

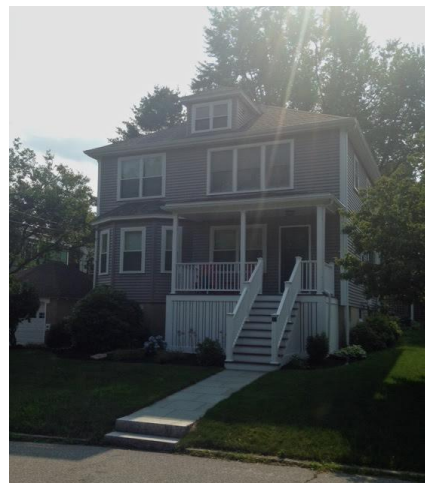
East (façade) elevation
