# FORM B – BUILDING

**Town/City:** Lexington

**Address:** 28 Theresa Avenue

**Recorded by:** Wendy Frontiero

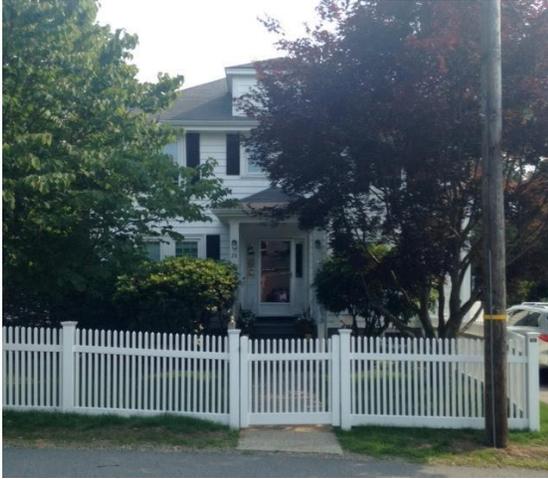
North (façade) elevation

The three by two bay main block rises 2 ½ stories from a foundation of brick and concrete block to a hip roof with a chimney on the west (right) slope. Walls are clad with vinyl and vinyl trim. Windows typically have 6/1 double hung sash with band molding. The front façade (north elevation) contains a projecting center entry portico composed of wood steps and railings, square posts, a hip roof, and a single-leaf door with half-height sidelights. Paired windows flank each side of the entrance on the first floor. One 6/1 window is set in each outer bay of the second floor, flanking a set of smaller paired windows above the entrance. A hip-roofed dormer is centered in the front slope of the roof; it contains a louvered attic vent.

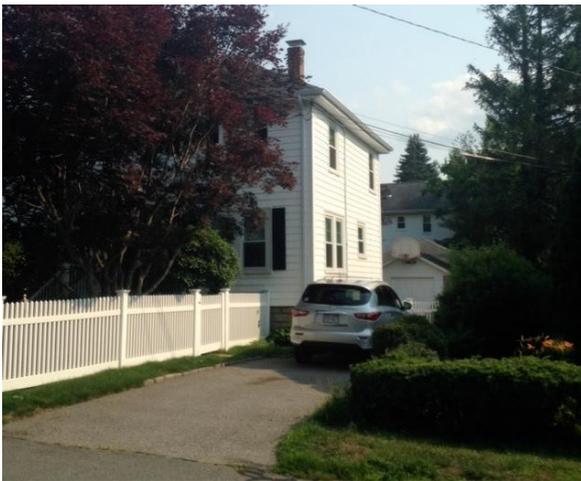
North (façade) and west (right side) elevations

The west (right side) elevation contains paired windows in the forward bay and a smaller window towards the rear of the first floor, and two widely spaced windows at the second floor. The asymmetrical east (left side) elevation contains two sets of paired windows at the first floor and two single windows at the second floor. A narrow sun porch is set slightly off-center on the rear elevation, with two windows on each side, four windows and an offset, single-leaf door on the back elevation, and a low hip roof. A triplet of windows occupies the easternmost bay of the first floor, and three windows are irregularly positioned on the second floor.

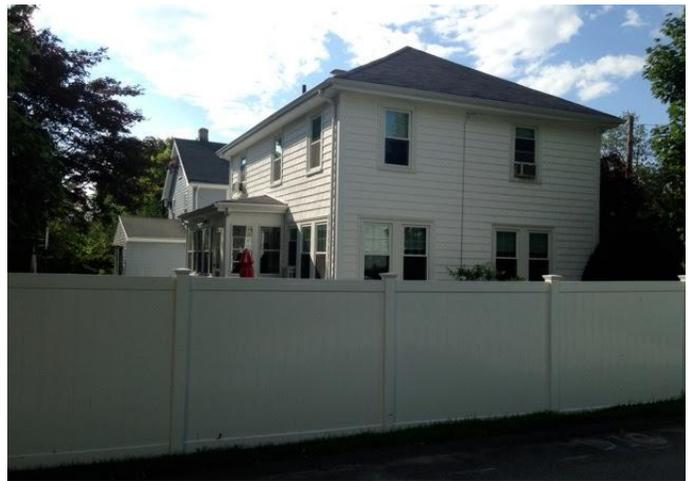
Rear (south) and east (left side) elevations
