FORM B – BUILDING

48/75A 2279

Town/City: Lexington

Address: 15 Vine Brook Road

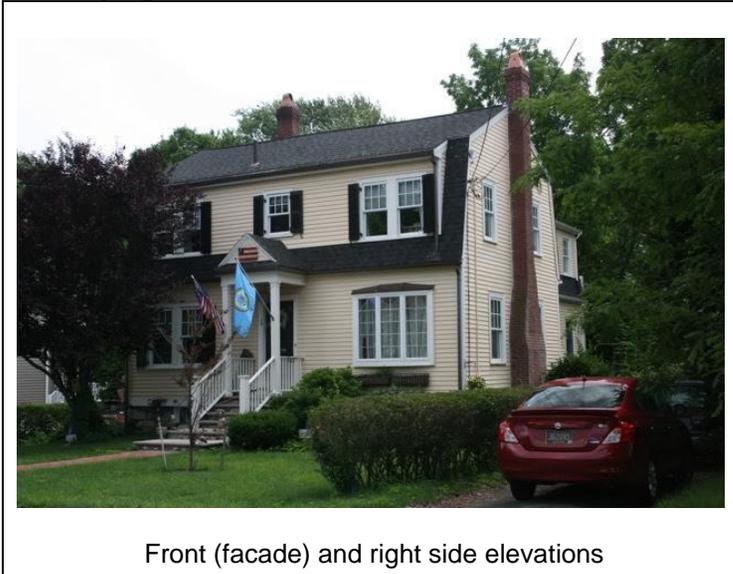
Photograph

The three by two bay main block rises from a raised basement to a side gambrel roof with no gambrel returns. The fieldstone foundation has deeply recessed joints. A long shed dormer extends nearly the full length of the façade. An exterior chimney rises along the right side elevation, and an off-center interior chimney rises from the back slope of the roof. Another exterior chimney is centered on the back wall of the rear addition. Walls are sheathed with wood clapboards and trimmed with plain sill boards and corner boards. Windows are typically 6/1 double hung replacement sash with narrow band molding. Louvered wood shutters are mounted on hinges and secured with S-shaped catches.

The gabled and pedimented roof of a tall, narrow entry portico (a later addition) is supported on slender Tuscan posts; it is centered between paired windows to the left and a shallow, modern bay window to the right. In the dormer, a small center window is flanked by paired windows to each side. The front portico is accessed by fieldstone steps that have slate treads and wood railings with square balusters.

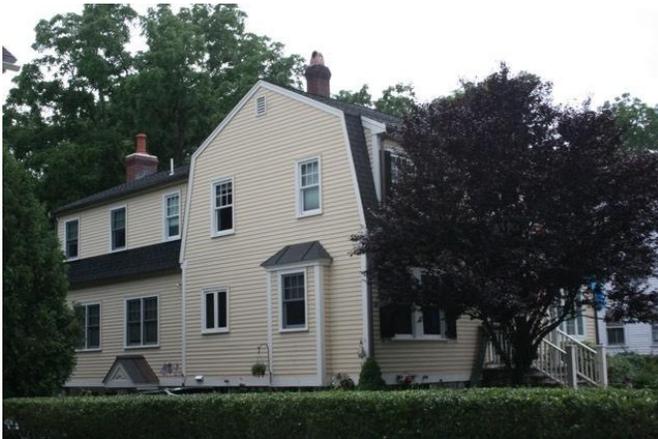
The left side elevation of the main block contains a shallow rectangular projection with a single window towards the front and a pair of casement windows towards the back of the first floor, and two widely spaced windows above. The right side elevation of the main block has a center exterior chimney flanked by one window on each side on each floor.

Left side and front (facade) elevations
