FORM B – BUILDING

48/222 2276

Town/City: Lexington

Address: 22 Vine Street

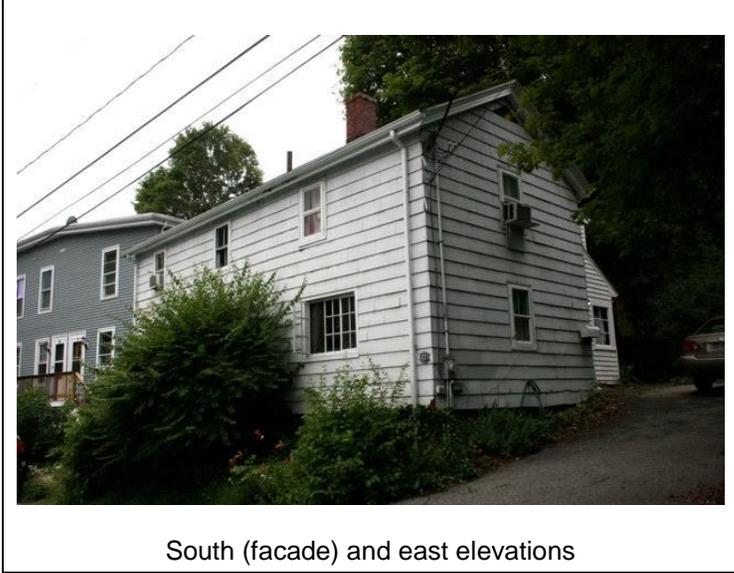
Photograph

Condition: fair

The three by one bay main block rises two stories from a concrete foundation to a shallow-pitched side gable roof; no gable returns. An interior chimney rises near the center of the front slope of the roof. Walls are clad with asbestos shingles. Windows are typically 2/2 double hung sash with narrow band molding. The asymmetrical façade contains a high proportion of solid wall area. A small double-hung window is centered on the first floor, flanked by a triplet of 6-light casement windows on each side. Three small double hung windows are arrayed close to the eave on the second floor. The basement contains short, double-leaf flush doors at the left end of the façade, with a small, contiguous 6/6 window near the corner.

The right (east) and left (west) side elevations are both symmetrical, with one small window centered on each floor. A one-story shed roofed addition across most of the back of the building is sheathed in wood clapboards. It has no windows on the left side, and an offset doorway (the main entrance to the house) and a modern six-pane window on the right side. A large shed-roofed dormer is visible on the right side of the addition.

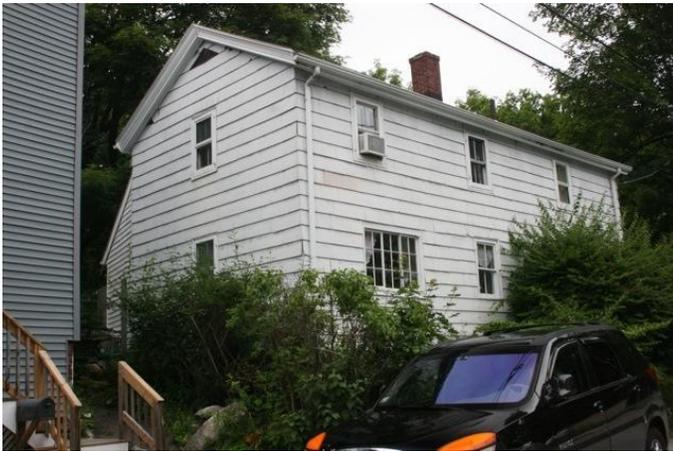
22 Vine Street occupies a small, thin lot that slopes significantly up from the street. The front of the building is set very close to the road, with a narrow setback on its left side and a paved driveway on its right side. The front and left side setbacks are mostly occupied by shrubs; trees and shrubs are scattered through the larger back yard.

West and south (facade) elevations
