FORM B – BUILDING

Town/City: Lexington

Address: 19 Welch Road

Style/Form: Queen Anne

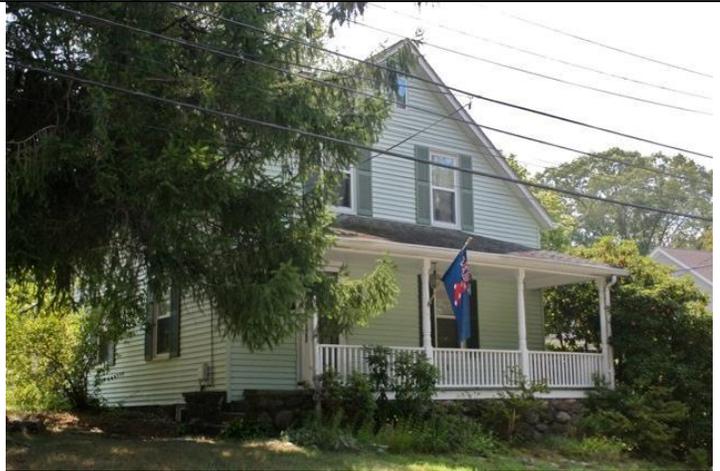
Left side and front (façade) elevation

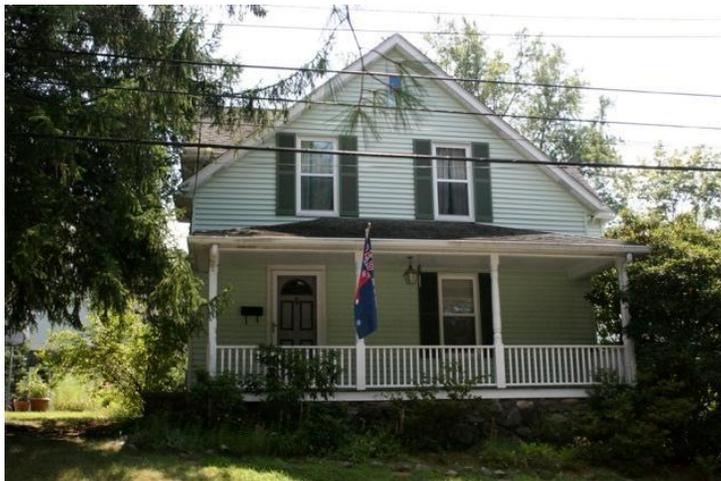
The main block rises 1 ½ stories from a fieldstone foundation to a front gable roof with no returns and one chimney on the right slope, near the center and ridge line. Walls are sheathed with artificial siding and trim. Windows typically have 1/1 double-hung replacement sash with no trim. The façade consists of a full-length front porch with a fieldstone foundation having deeply recessed joints, four decoratively turned posts, a low hip roof, and square wood balusters at the railing. An off-set, single-leaf doorway under the left side of the porch comprises the main entrance, with a single window to the right. Two windows are centered in the half story, with a tiny vertical opening in the gable peak.

Front (façade) elevation
