ORM B – BUILDING

Town: Lexington

Address: 92 Adams Street

Historic Name: McLaughlin-Lidberg House

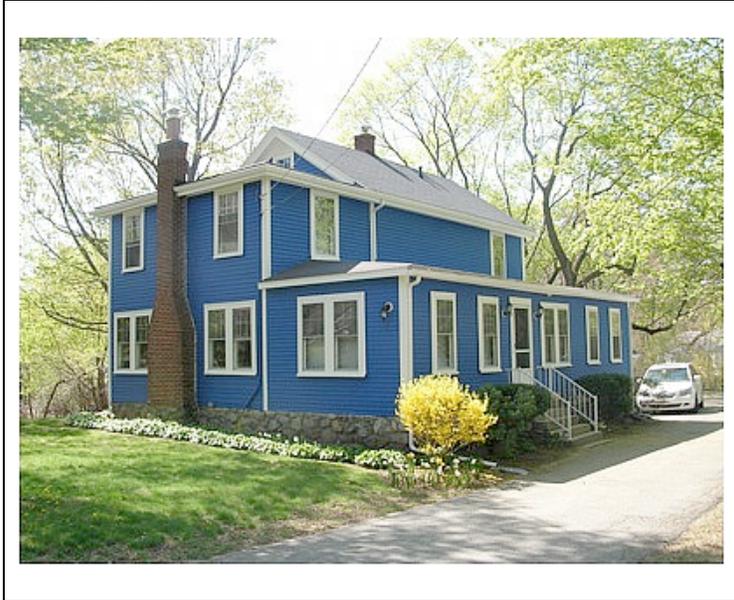
Photograph

Condition: good

The house at 92 Adams Street has seen a number of changes since its construction in the late 19th century although the dates of the alterations is not clear. The 2 ½-story house is sheathed in wood clapboards and is oriented with its southeast-facing gablefront to the street. The gablefront is obscured by a later, two-story, flat-roofed front addition which rests on a mortared stone foundation as does the single-story section (former porch?) spanning the long, east elevation. The predominant window throughout the house is a double-hung 6/1 window set into a molded surround and used individually or in pairs. Centered on the front addition is an exterior brick chimney; on the first floor the chimney is flanked on either side by a pair of 6/1 windows with two individual 6/1 windows on the second floor. A single-story, hip-roofed projection is located on the west elevation and is also set on a stone foundation. An additional brick chimney rises near the ridge of the asphalt-shingled gable roof. An attached, single-story, gable-roofed garage is located behind the main house block, with openings on the east side.
