# FORM B – BUILDING

**Town/City:** Lexington

**Address:** 92 Bedford Street

# INVENTORY FORM B CONTINUATION SHEET

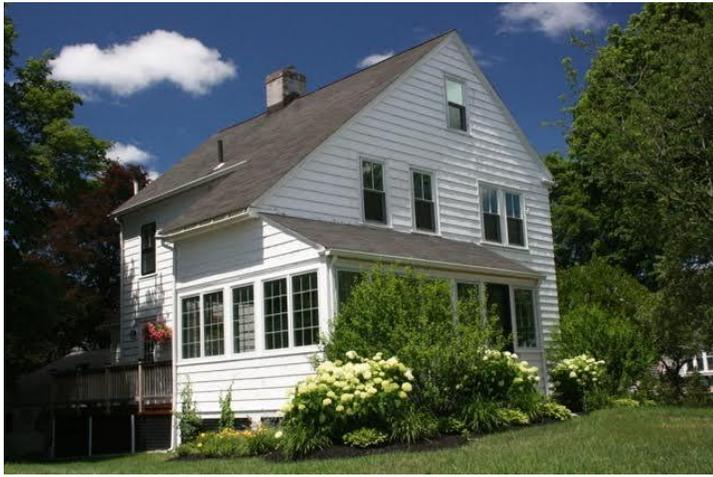
Left side and front (facade) elevations

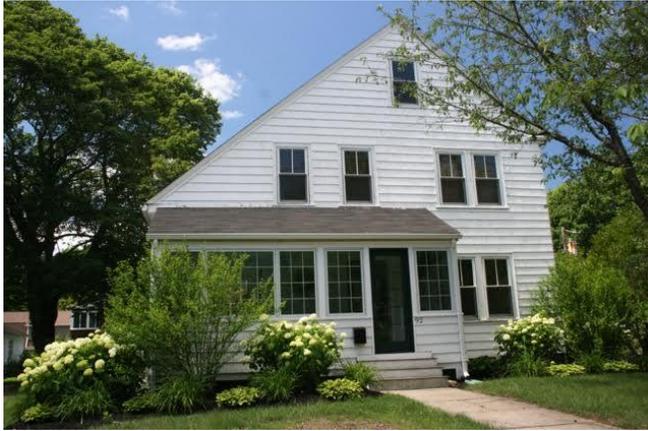
The main block rises from a rubble and fieldstone foundation (with faint suggestions of quoins at some corners) to a front gable roof with a saltbox extension at the Bedford Street façade; no gable returns. Walls are clad with wood shingles and trimmed with a simple cornice molding. Windows typically have 1/1 double hung sash with a narrow band molding. The asymmetrical front facade has a one-story enclosed porch along most of its length, with a shed roof and original/early (wood and glass panel) door, and two single windows above. Vertically aligned, paired windows occupy the remaining bay of the façade on the first two floors. A small double-hung window is set in the half story.

Front (facade) elevation

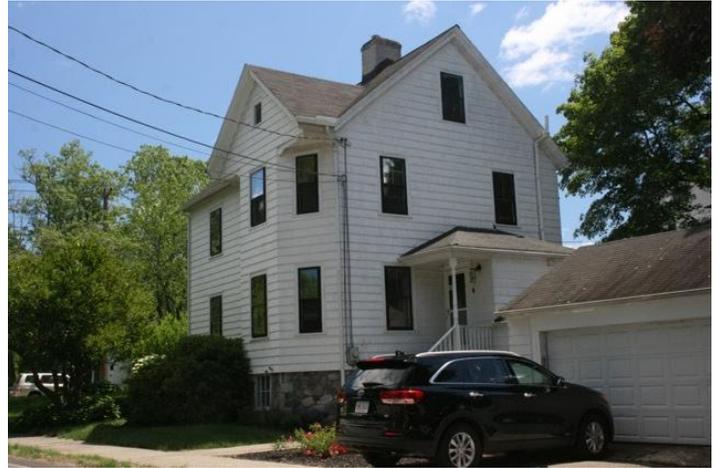
The left side elevation has two bays on the main block, with single windows on both floors and an offset single-leaf door accessing a contemporary wood deck along the full length of this wall. The right side (Tewksbury Street) elevation features, towards the back, a large, 2 ½ story angled bay with decoratively sawn brackets at the eaves, one window on each angled face, and a small window in its half-story. The forward bay of this elevation contains vertically aligned single windows. The asymmetrical rear elevation contains a small, one-story entry vestibule with a hip roof and a side-facing, single-leaf door; two slightly asymmetrical windows on the second floor, and one window centered in the half story.

Right side and back elevations

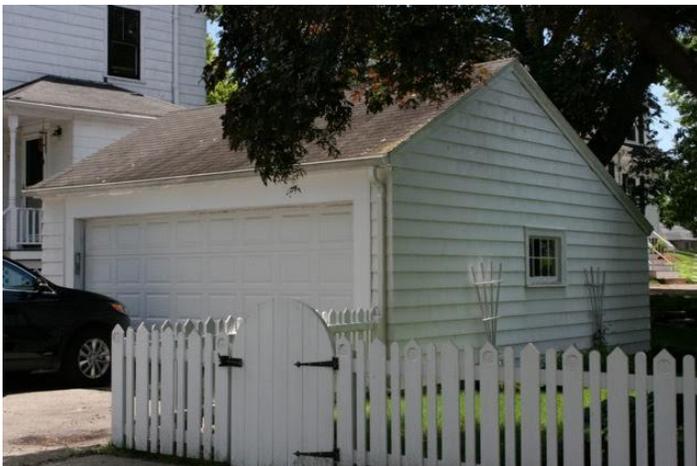
A narrow, gabled breezeway connects the back of the house to the attached garage. The garage has one wide vehicle bay, a side gable saltbox roof, and wood shingles and trim. One eight-light window is asymmetrically set on its right side elevation, and the rear elevation has two symmetrically placed, eight-light sash.

Garage: Front (façade) and right side elevations
