FORM B – BUILDING

Address: 99 Bow Street (at Winn Ave.)

Historic Name: Dionizia DeMarties (Demattis) House

99 BOW STREET

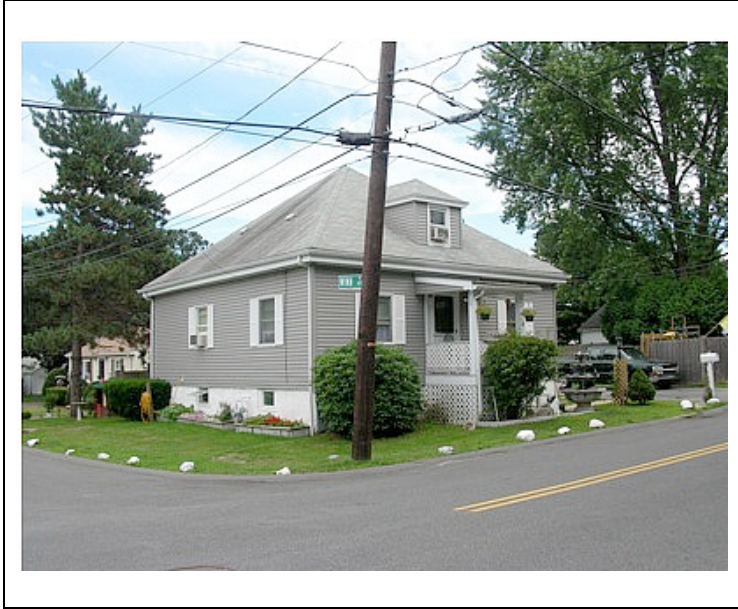
Photograph

The house at 99 Bow Street is the best preserved of several similar modest, hip-roofed dwellings in this neighborhood (others include 89 Bow Street and 107 Bow Street). Until recently, the house retained a clapboarded exterior; it is now sheathed in vinyl siding. The steeply-pitched hip roof is sheathed in asphalt shingles and there is a hip dormer centered on the front slope. The façade is three bays wide with a shed-roofed porch sheltering the center entrance. The windows contain 1/1 replacement sash and are flanked by shutters. A deck has been added on the south side.
