FORM B – BUILDING

13/270 2206

Town/City: Lexington

Address: 23 Charles Street

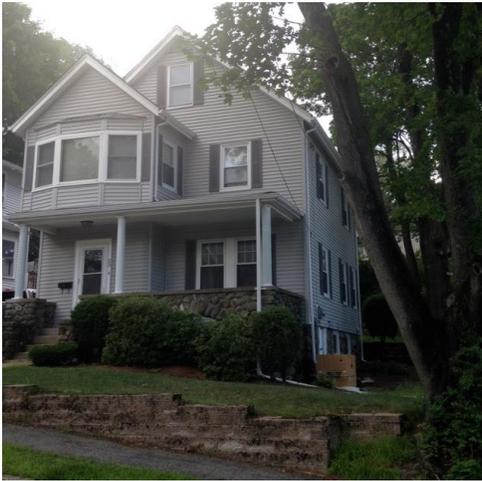
East (façade) and north (right side) elevations

The rectangular building rises 2 ½ stories from a fieldstone foundation to a front gable roof with no returns and a center chimney. Walls are sheathed in vinyl with vinyl trim. Windows typically have 6/1 or 1/1 double hung replacement sash with vinyl trim. The front façade (east elevation) is spanned by a one-story porch with concrete steps framed by fieldstone cheek walls, half-height fieldstone walls surmounted by Tuscan columns, and a low hip roof. An offset entry door is located in a shallow projecting bay on the left, with paired 6/1 windows to the right. A large cross-gabled pavilion is centered over the entrance bay. It contains an angled bay window on its front face and single windows on its sides. A single 1/1 window is set in the right-hand bay of the second floor, and a 1/1 window is centered in the half story of the facade.

The asymmetrical north (right side) elevation has two large windows and an offset doorway in its partially exposed basement, three windows on the first floor, and two on the second. The more irregular south (left side) elevation has one window visible on the first floor, three of varied size on the second floor, and one intermediate level window near the center, suggesting an interior stairway. A small shed-roofed entry vestibule projects from the center of this elevation, with a single-leaf doorway facing the driveway and a 1/1 window facing the street.

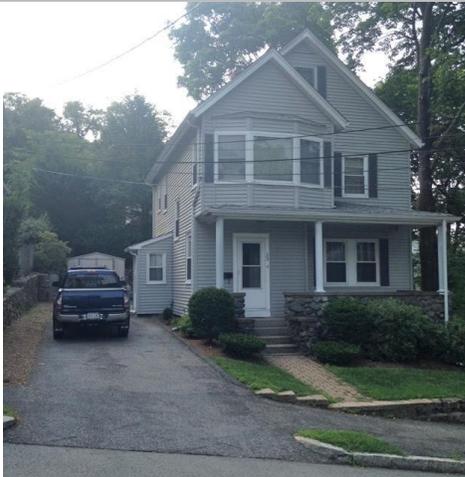
South (right side) and east (façade) elevations
