FORM B – BUILDING

Town/City: Lexington

Address: 23 Charles Street

23 CHARLES STREET

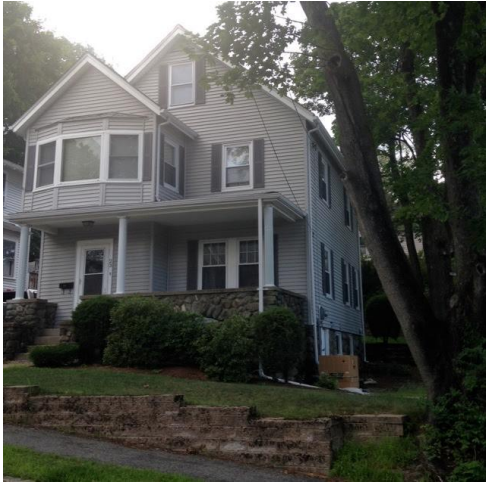
East (façade) and north (right side) elevations

The rectangular building rises 2 ½ stories from a fieldstone foundation to a front gable roof with no returns and a center chimney. Walls are sheathed in vinyl with vinyl trim. Windows typically have 6/1 or 1/1 double hung replacement sash with vinyl trim. The front façade (east elevation) is spanned by a one-story porch with concrete steps framed by fieldstone cheek walls, half-height fieldstone walls surmounted by Tuscan columns, and a low hip roof. An offset entry door is located in a shallow projecting bay on the left, with paired 6/1 windows to the right. A large cross-gabled pavilion is centered over the entrance bay. It contains an angled bay window on its front face and single windows on its sides. A single 1/1 window is set in the right-hand bay of the second floor, and a 1/1 window is centered in the half story of the facade.

The asymmetrical north (right side) elevation has two large windows and an offset doorway in its partially exposed basement, three windows on the first floor, and two on the second. The more irregular south (left side) elevation has one window visible on the first floor, three of varied size on the second floor, and one intermediate level window near the center, suggesting an interior stairway. A small shed-roofed entry vestibule projects from the center of this elevation, with a single-leaf doorway facing the driveway and a 1/1 window facing the street.

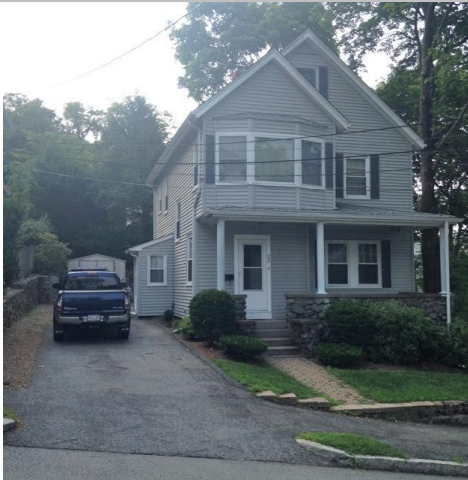
South (right side) and east (façade) elevations
