# FORM B – BUILDING

**Address:** 26 Hayes Avenue

**Historic Name:** Henry L. & Marion Wadsworth House

LEXINGTON

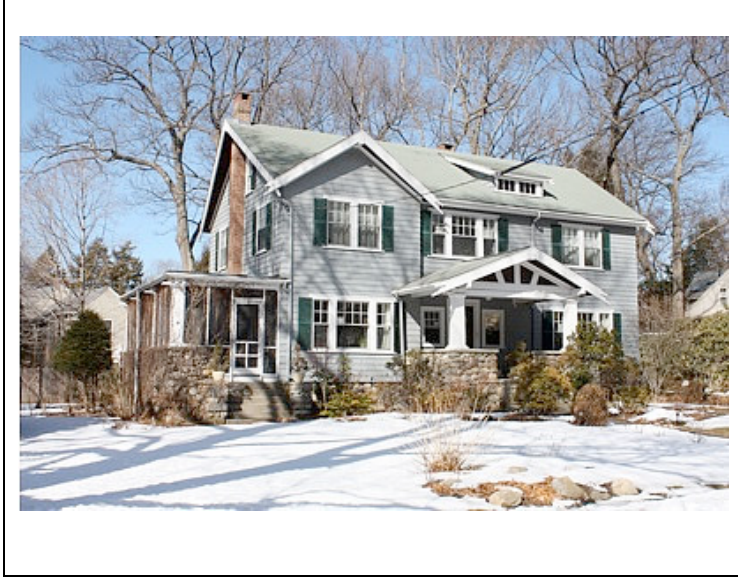
## Photograph

**Condition:** good

The house at 26 Hayes Avenue is an expression of the Craftsman style applied to a 2 ½-story, side-gabled form. The house is set on a rubble foundation with stonework also supporting the front and side porches. The exterior is sheathed in wood shingles and the asphalt-shingled roof displays an unusual tapered overhang which is of greatest depth at the apex of the gables. The ends of the gable rakings and other projections display a decorative notched effect and are supported by decorative beams at the top and base of the gables. A projecting two-story gable at the west end of the façade gives visual interest to the three-bay wide façade. The front porch gable is half timbered and the roof is supported by bold, tapered posts. At the west end of the house a brick exterior chimney emerges from the roof adjacent to a single-story porch. Windows include a mix of tripartite, paired and individual wooden windows with 4/1, 6/1, and 8/1 sash in molded surrounds, with shutters. There is a fixed sash with geometric tracery lighting the shed-roofed bay window on the east wall and a shed dormer emerging from the front slope.
