FORM B – BUILDING

Town: Lexington

Address: 46 Lincoln Street

Historic Name: Pumping Station Engineer's House

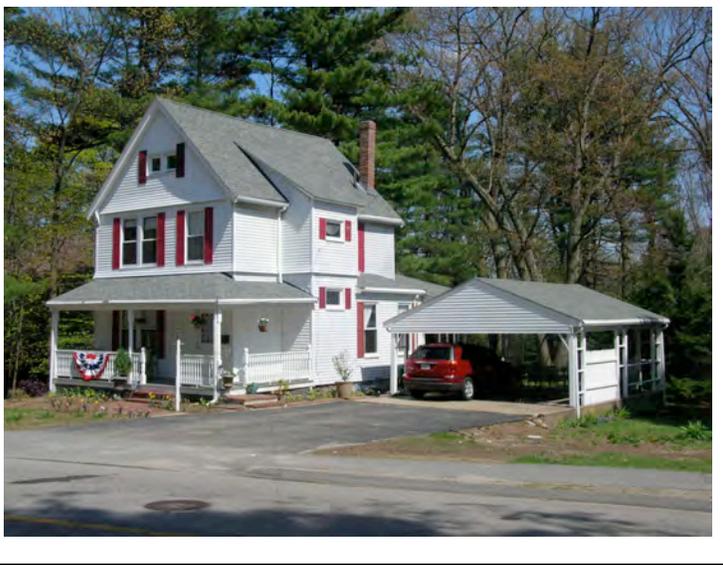
Photograph

c.2000 – vinyl siding and new windows

Condition: fair (due to siding)

Dating to the late 19th century, the house at 46 Lincoln Street is a 2 ½-story gablefront structure which is set on a mortared stone foundation and is presently sheathed in vinyl siding. The overhang of the gable pent and the bracket supports at the base of the gable suggest that at least part of the building may have originally been sheathed in wood shingles. The roof is covered with asphalt shingles and a brick chimney emerges near the southwest corner. A single-story porch supported by bold turned posts wraps around the façade and part of the west elevation, terminating at a two-story, shed-roofed projection located midway on the west side. In addition to the turned posts the porch also has a turned balustrade. The sidehall entry has a modern replacement door. Most of the windows contain double-hung 1/1 sash. There is a pair of 1/1 windows adjacent to the front door and another set aligned above. Other smaller, single-pane openings light the attic and west shed projection.
