FORM B - BUILDING

Massachusetts Historical Commission

Address 25 Adams Street

Historic Name George & Anna Russell House

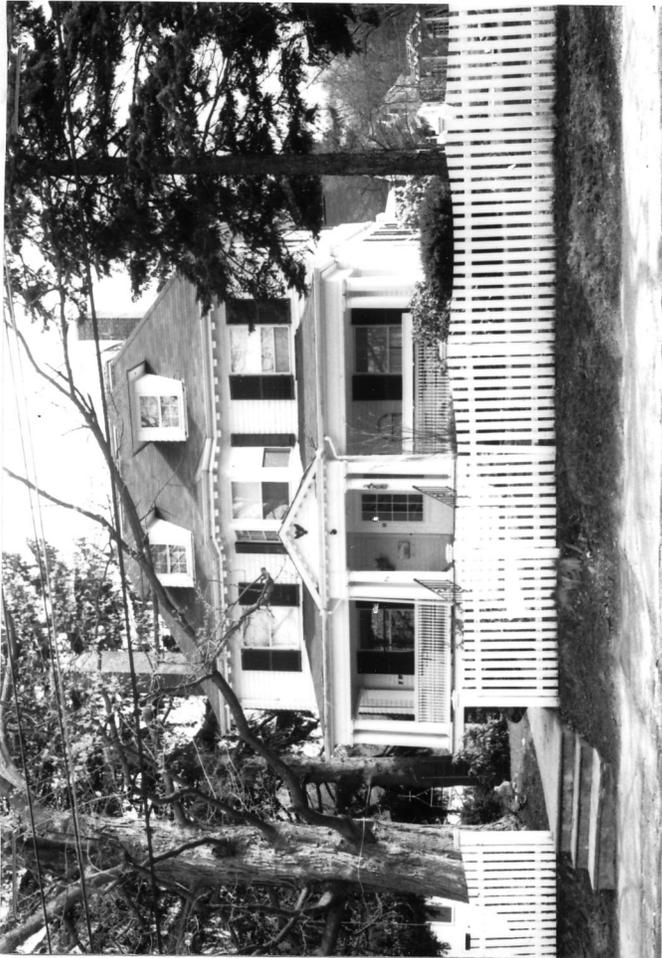
Located at the northeast corner of Adams and Meriam Streets, 25 Adams Street (MHC #1019) is a good example of the Colonial Revival style of the early 20th century. The two-story, hip-roofed dwelling is set above a rubble foundation and sheathed in wood shingles. The three-bay facade is spanned by a single-story porch supported by clusters of three Roman Doric columns that are echoed by single pilasters mounted on the facade. The columns are spanned by a turned balustrade. A center pediment decorated by modillions marks the entrance. Both the pediment and adjacent porch display a plain frieze. The entrance is sheltered by a glazed projecting vestibule and is flanked by large 2/2 windows with blinds. Above the entrance, on the second floor of the facade, a three-sided bay window rests on the porch roof and is lit by 2/1 windows with the adjacent windows identical to those on the first floor. A bold modilion cornice wraps around the building and a pair of hip-roofed dormers rise from the front and rear roof slopes. The asphalt-shingled hip roof is crowned by a balustrade of simple square posts arranged in an intersecting, star-like pattern.

On the remaining elevations, the shingles are flared between the first and second stories. There is an exterior brick chimney on the north elevation and a single-story, three-sided bay window.

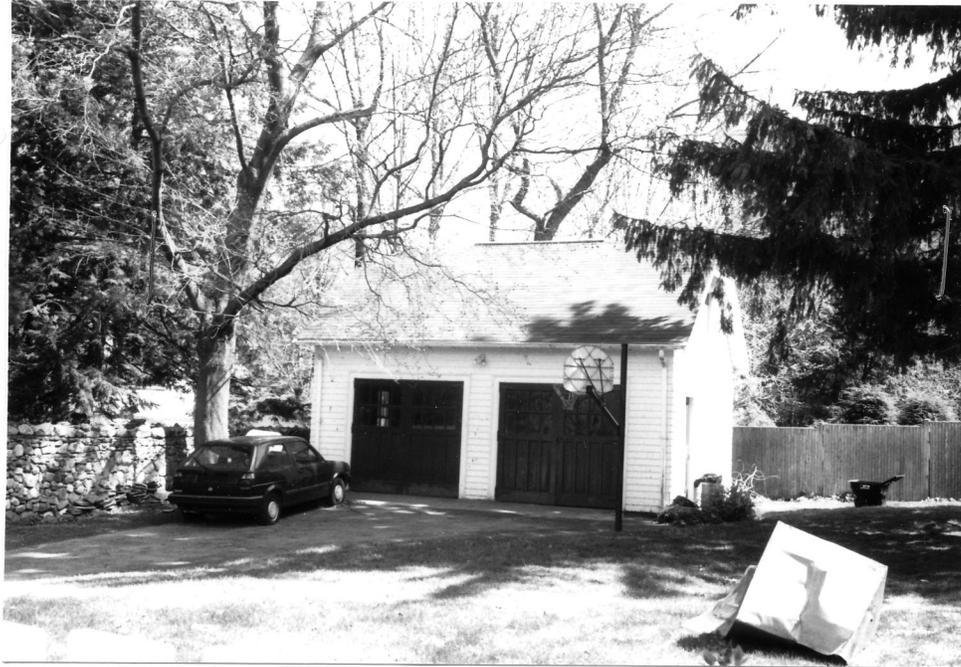
The yard is enclosed by a simple wooden picket fence and there is a mature maple tree adjacent to the concrete front walk with large pine trees near Meriam Street. A stone wall marks the northern property line. To the north of the house is a side-gabled, wood-shingled garage (MHC #1020) which is capped by a jerkinhead roof. There are two sets of double doors on the broad facade. Each leaf displays 4 x 2 lights over four vertical panels. Other fenestration on the garage includes a 6/1 window and a vertical board door in the attic.
