# FORM B – BUILDING

**Town/City:** Lexington

**Address:** 1-3 Belfry Terrace

**Date** (*month / year*): September 2015

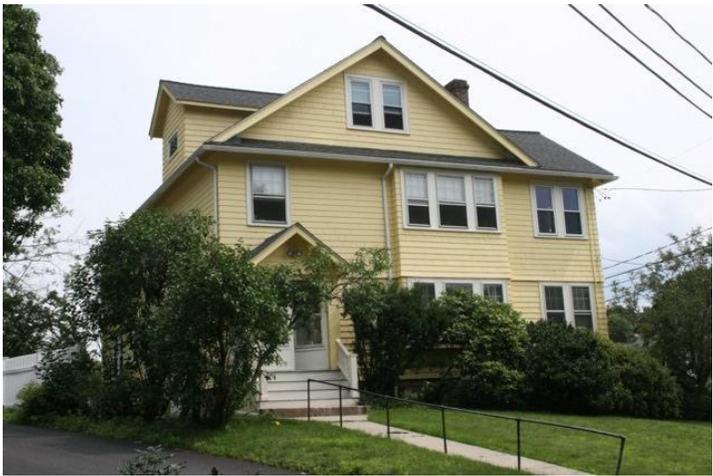
Left side and front (facade) elevations

On the main, Belfry Terrace façade, a large pedimented gable surmounts a shallow rectangular bay window on one side and an offset entrance. The bay window has a triplet of windows on each floor. The enclosed entrance vestibule has a gabled roof with exposed rafter ends and horizontal beams with shaped ends and a shingled tympanum. Its side-by-side doors (original or early with wood and glass panels) are accessed by broad wood steps having wood railings with square balusters. To the right of the façade gable, each floor has a bay of paired windows. The skirted base of the pedimented gable frames a pair of windows in the tympanum.

The left side elevation of the house is asymmetrically composed, with two pairs of windows on each floor flanking a small center window towards the back of this elevation. A single leaf entrance is located towards the front, along with an offset gabled dormer with a small horizontal casement window in the center. On the right (Forest Street) side of the building, a cross-gabled extension of the front façade contains two individual garage bays at the basement level, a triplet of windows on each of the two floors above, and a skirted base on the pedimented gable end.

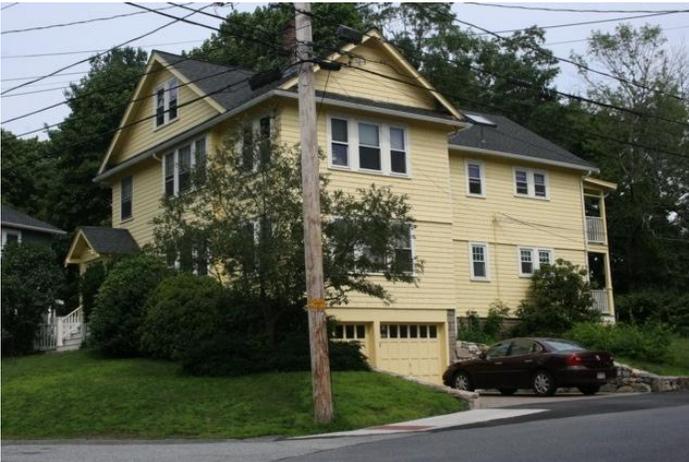
Front (facade) and right side elevations

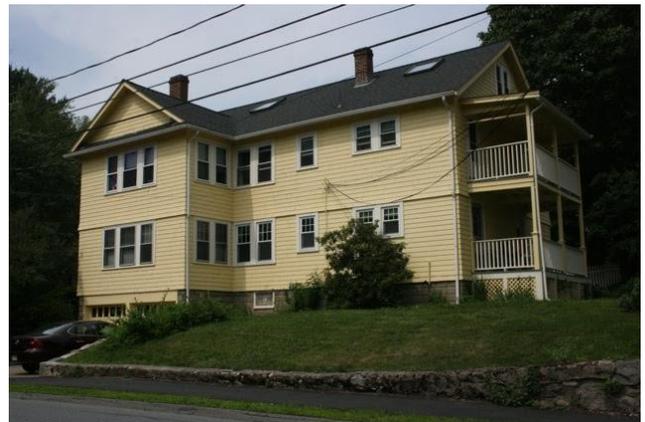
Right side and back elevations

The rear wing of the house has irregular fenestration consisting of paired and single windows along Forest Street. Two stacked, one by two bay porches on the back of the wing are composed of a shallow pitched roof with exposed joists, square wood posts, and modern wood railings with square balusters. Single leaf doors access both porches. Paired windows are set above the porches at the attic level.
