FORM B – BUILDING

Address 130 Burlington St.

Historic Name Stephen Locke House

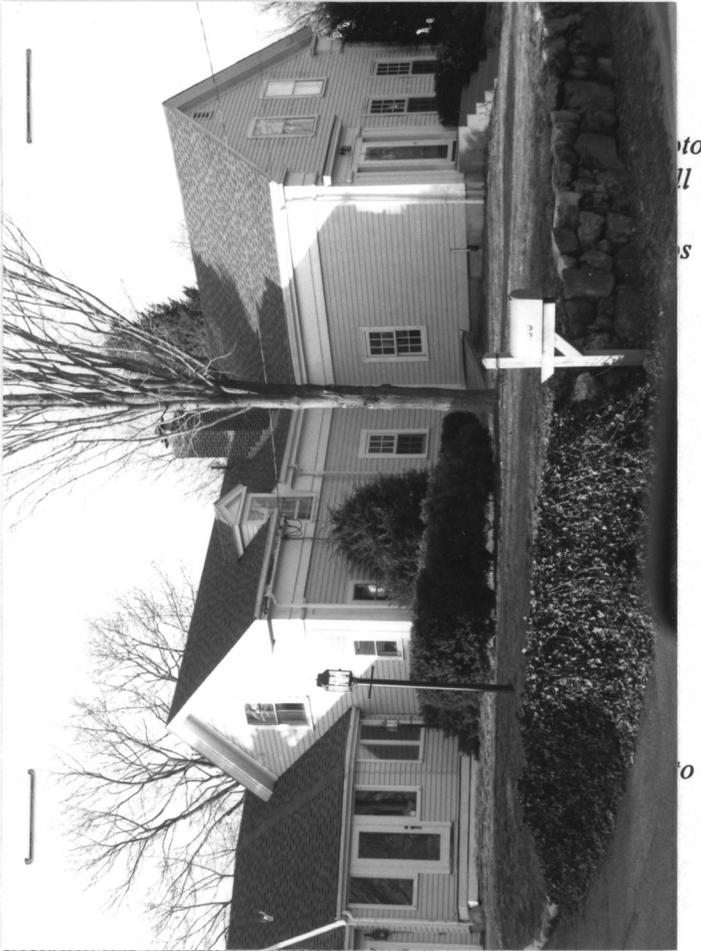
130 Burlington St. is one of only six front-gabled Greek Revival cottages in Lexington and has more elaborate period finishes than the others. The original house is a front-facing L, 1½ stories, and cross-gabled; the front-gabled arm is three-by-three bays, the side-gabled arm three-by-two bays with a side chimney. An enclosed sun porch has been added on the east elevation and, on the west, an unsympathetic one-story side-gabled addition with casement windows and a secondary entrance that connects with a recent two-car garage. The original house is set on a granite foundation, the facade clad with vinyl siding and the rest with wood clapboards, and roofed with asphalt shingles. The main entry on the facade has a surround with a molded projecting cornice, paneled pilasters, and full length sidelights; windows are 9/9 double hung sash on the first floor of the facade and 6/6 elsewhere. In addition to the entry surround, Greek Revival finishes include paneled cornerboards and a full entablature on the side elevations.
