FORM B – BUILDING

Town/City: Lexington

Address: 10 Crescent Hill Avenue

Recorded by: Wendy Frontiero

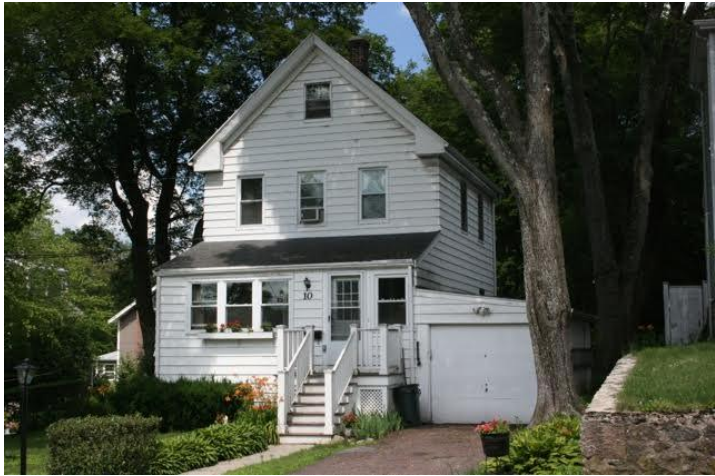
Photograph

Front (facade) and right side elevations

The three by two bay rectangular main block with a small side ell rises 2 ½ stories to a front gable roof with gabled returns that have been boxed in. One interior chimney is located at the center of the ridge line. A one-bay deep, one-story addition across the front of the house has a shed roof; it may represent an enclosed porch. Windows are typically 1/1 replacement sash without trim. One 2/2 sash remains in the attic story. The façade (west) elevation has an offset, single-leaf doorway and one single, one paired, and one triple window on its one-story addition. Its small entry porch contains wood railings with square balusters and wood steps. The left (north) side elevation features two symmetrical, widely spaced windows on each floor. The right (south) elevation has two asymmetrically placed windows on the second floor and an attached garage on the first floor. The garage features a shed roof, one vehicle bay facing the street, and two six-light windows on its right (south) side. A tall fieldstone retaining wall extends along the uphill (right) side of the property.

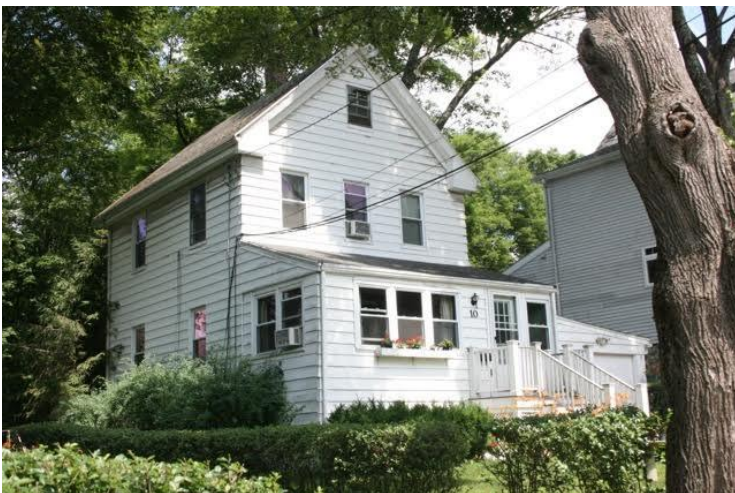
Left side and front (facade) elevations
