FORM B – BUILDING

59/24C [] [] [] 2218

Town/City: Lexington

Address: 11 Fairview Avenue

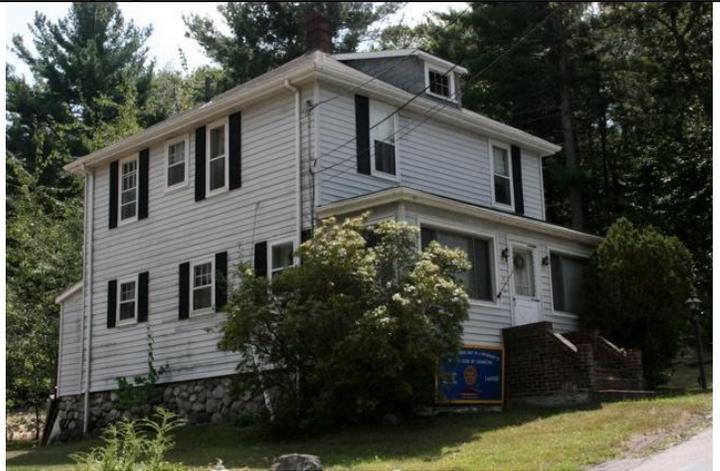
Photograph

Left side and front (façade) elevations

The small rectangular house rises 2 ½ stories from a fieldstone foundation with deeply recessed joints to a hip roof with a single, shed-roofed dormer on the front slope. One chimney projects from the right slope of the roof, near the peak. Walls are clad with artificial siding and trim. Windows typically have 6/1 double hung wood sash or 1/1 replacement sash with aluminum trim. The first floor of the front (Fairview Street) facade is spanned by an enclosed sun porch with a hip roof, center door, modern picture window units, and a brick stairway with brick cheek walls. Two widely spaced 6/1 windows are symmetrically set on the second floor, and the dormer contains a horizontal, six-light window sash.

11 Fairview Avenue is a very modest example of early 20th century housing in an outlying area of Lexington. The house is notable for its intact massing, rustic masonry foundation, and some original or early window sash.

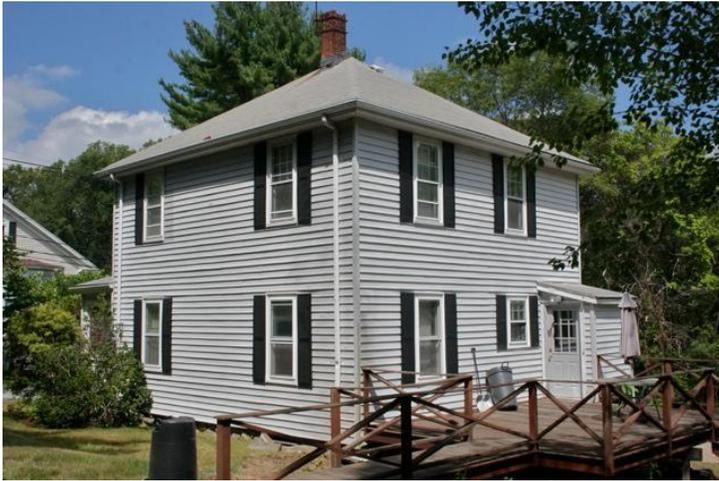
The symmetrical right side elevation has two widely spaced window bays with one window on each floor (6/1 sash on the second floor, 1/1 on the first). The irregular left side elevation has a variety of window sizes and mostly 6/1 sash, with three smaller windows on the first floor and three taller windows at the second floor. On the rear elevation, the first floor has a modern wood deck with cross-braced railings and a small shed-roofed entry vestibule at the back left corner, with a single-leaf door facing the right side of the property. There are two window bays with one window on each floor, three of them having 6/1 sash.

Right side and rear elevations
