FORM B – BUILDING

Town/City: Lexington

Address: 10 King Street

Recorded by: Wendy Frontiero

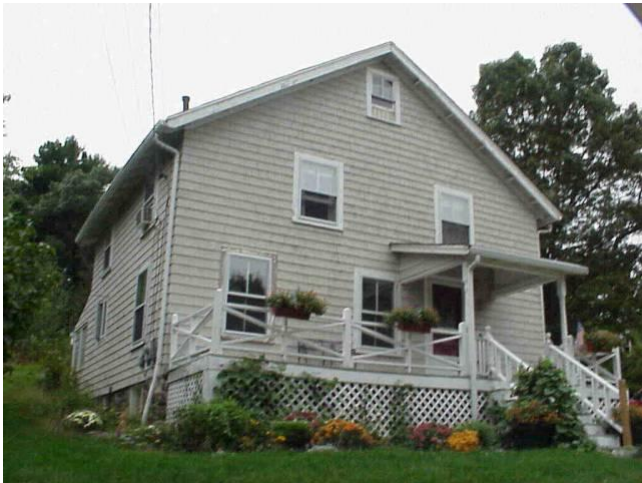
The south (left side) elevation contains two widely spaced window bays, with two 6/1 windows on each floor. The north (right side) elevation has a single four-pane window towards the front corner. A wide, cross-gabled ell occupies the rear portion of this elevation, rising 1 ½ stories. On the elevation facing the street, this addition displays a single leaf entry at grade and single window above. Its north elevation contains three regularly spaced, square awning windows on the first level and a band of four grouped, square awning windows above. Purlin and rafter ends are exposed at the eaves of the ell roof.

Assessors' photograph:
South (left side) and east (façade) elevations
