FORM B – BUILDING

Town/City: Lexington

Address: 8 Locust Avenue

Recorded by: Wendy Frontiero

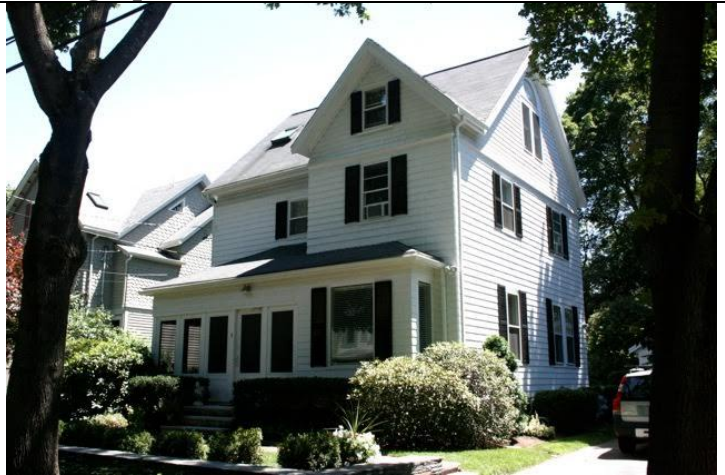
Front (façade) and right side elevations

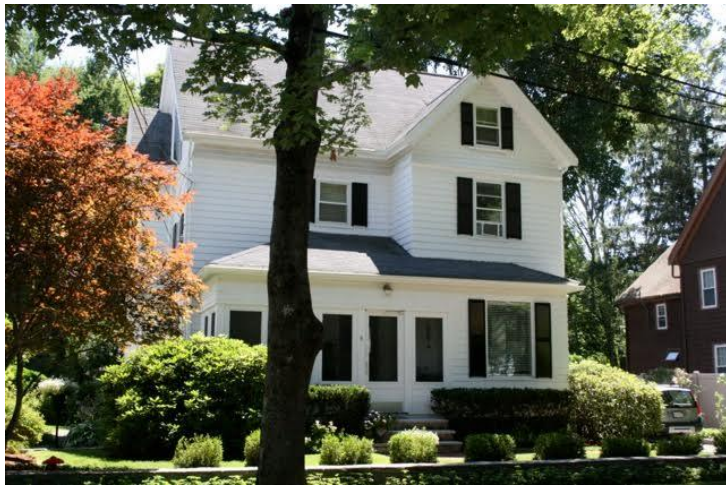
The left side elevation of the main block has a two-story cross-gabled bay window towards the rear whose first floor is angled, with decoratively sawn brackets supporting the rectangular upper level. The flat bay of this elevation has one original window on the lower two floors and a modern casement window with a semicircular transom at the half-story. The right side elevation is two bays deep, with one individual window and a paired set of windows on the first floor, two widely spaced windows on the second floor, and paired windows with a large semi-circular transom at the half-story.

Left side and front (façade) elevations

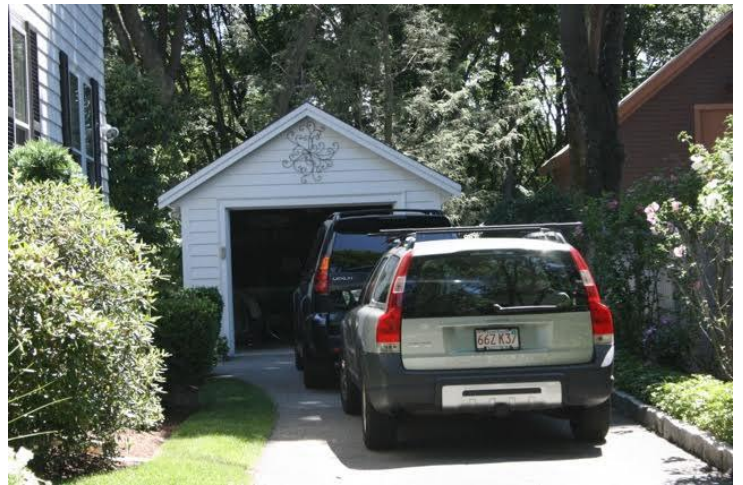
A detached garage set behind and to the right of the house has one vehicle bay, a front gable roof, and wood shingles and trim.

Garage
