FORM B – BUILDING

Town: Lexington

Address: 2377 Massachusetts Avenue

Historic Name: Dennis McNamara House

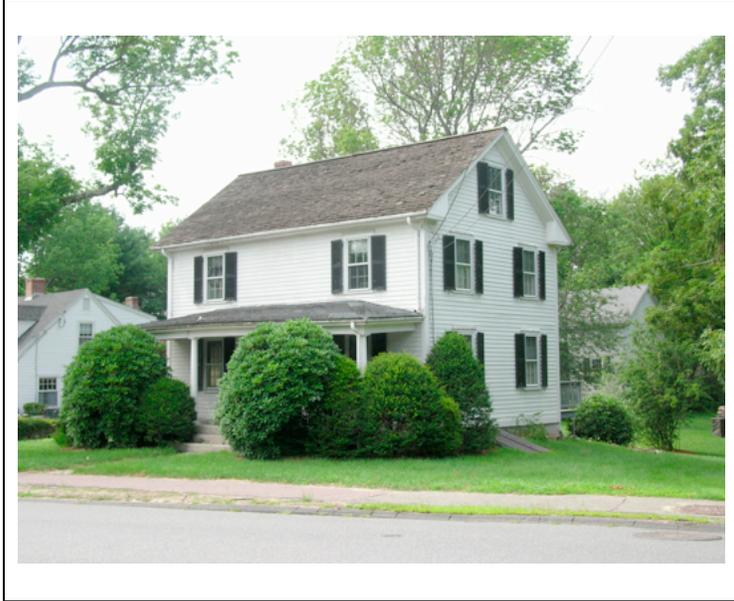
Photograph

Condition: good

2377 Massachusetts Avenue is a well-preserved 2 ½-story, 3 x 2-bay, side-gabled dwelling dating to the mid 19th century. Set on a granite foundation, the house is sheathed in wood clapboards and capped by a gable roof with projecting eaves that end in returns on the gable ends. The house is fronted by a single-story porch supported by Doric columns that appears to date to the early 20th century. The Colonial Revival entrance is a more recent alteration. Windows contain 6/6 wooden sash and are capped by projecting shed lintels. A modern deck is located to the rear and an exterior brick chimney has been added on the west end.

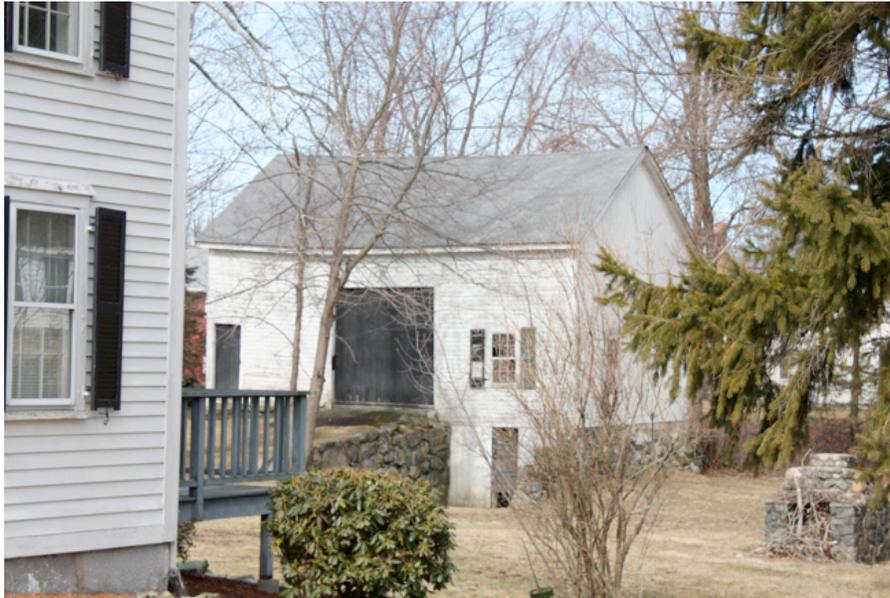
Behind the house is a side-hill English barn which is sheathed primarily in wood clapboards with vertical boards on the gable ends. The barn is set on a rubble foundation. The large vertical board barn door on the façade is fronted by a grassy ramp with a stone retaining wall along the east side allowing for access to the lower level. Other fenestration includes 6/6 windows.
