FORM B - BUILDING

AREA	FORM NO.
	593

Town Lexington

Address 2 Middle Street

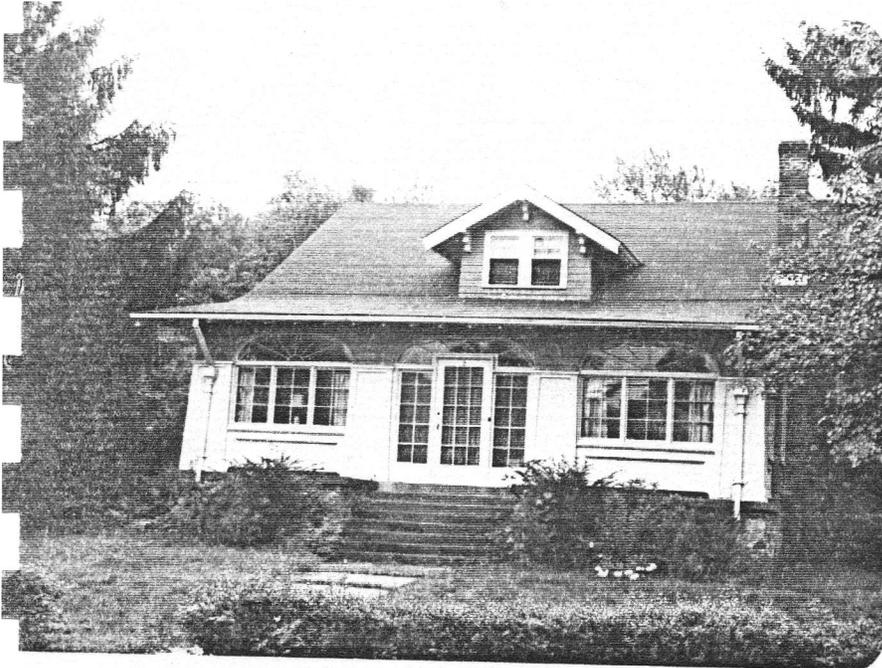
This high-style bungalow is the only one of its kind in a neighborhood of generally more recent houses. It has distinctive elliptical fanlights with tracery over the sunporch casement windows and front door. The battered porch posts are covered with vertical panels up to the overhang and this detail is repeated in horizontal panels under the sunporch windows. The gable roof curves into wide, flaring eaves with the rafter ends visible. The overhangs on the gable ends of both the main and dormer roofs have purlins supported by

stepped brackets; on the main roof the ends of the purlins are emphasized by small, raised rectangular panels on the fascia boards. The foundation is of fieldstone; the end chimney of brick. The two-car garage has a gable roof with small, raised rectangular panels on the fascia boards that repeat the similar detail on the house.
